Microscopy Analysis in CFRP and GFRP Composites Manufactured by LCM and Autoclave Techniques

M. Moreno-Rios^{1*}, J. C. Mendoza Mendoza¹, E.O. Avila-Davila¹, E. E. Vera-Cárdenas¹, S. Ledesma-Ledesma² and A. I. Martínez Pérez³

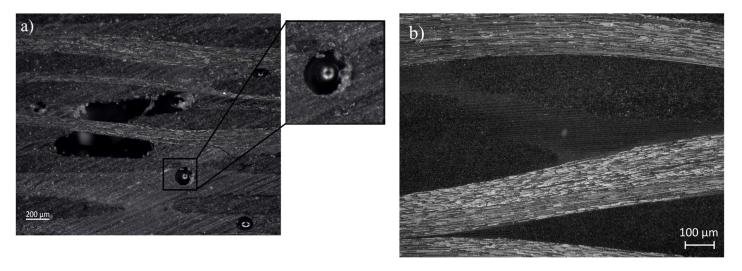
As show in Figure 1 a), the composite CFRP manufactured by LCM has some voids with spherical shape, the average size range of 116 to 165 µm approximately, there are also other voids with elliptical shape with 1 mm longitudinal size, and these defects are in the interface between the carbon fiber and the polymer matrix. In the Figure 1 b), the same composite manufactured by autoclave technique, showed a good adhesion in the interface between the carbon fibers and the matrix, and there were not voids observed. In the Figure 2 a) and b) the sectional view GFRP composites manufactured by LCM and autoclave technique, respectively, is showed. Figure 2 a) shows an interface with fiber bundles and in the polymer matrix there were small voids with irregular round shapes an average size range of 10-20 µm, approximately. In the Figure 2 b), microscopic examination indicated that, there was good adhesion between the matrix and the glass fiber without presence of voids.

Figure 1. Cross Section of CFRP composites. a) LCD technique, b) autoclave process.

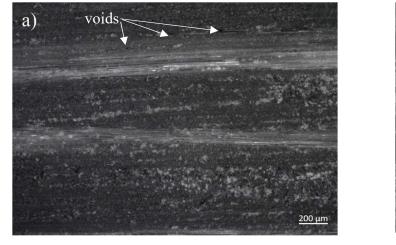
Figure 2. Cross Section of GFRP composites. a) LCD technique, b) autoclave process.
