## Cracking of GaN Based III-Nitride Heterostructures Grown by MOVPE on (0001)-6H-SiC

A. Hasenkopf,<sup>a,b</sup> F. Scholz,<sup>b</sup> F. Phillipp<sup>a</sup>

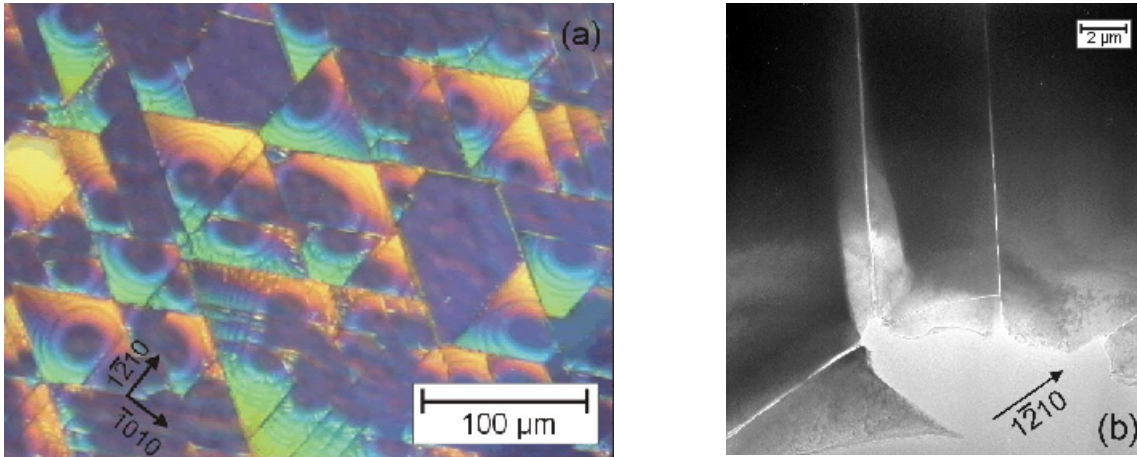
FIG. 1. Optical micrograph of the surface of a GaN multilayer laser structure showing cracks and interference fringes (a) and TEM plan-view micrograph of the same sample confirming the cracks running along the crystallographic directions (b).

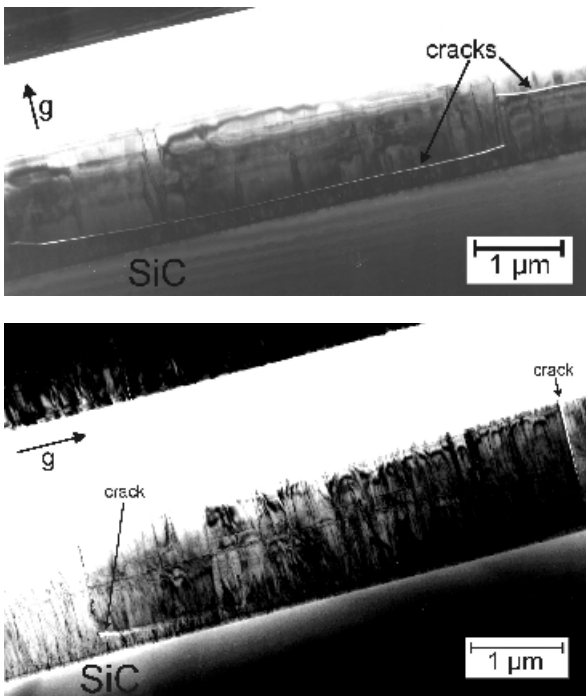
FIG. 2. TEM cross section micrographs of two heterostructures showing both cracks running almost parallel to the (0001) plane and along the (0001) direction.

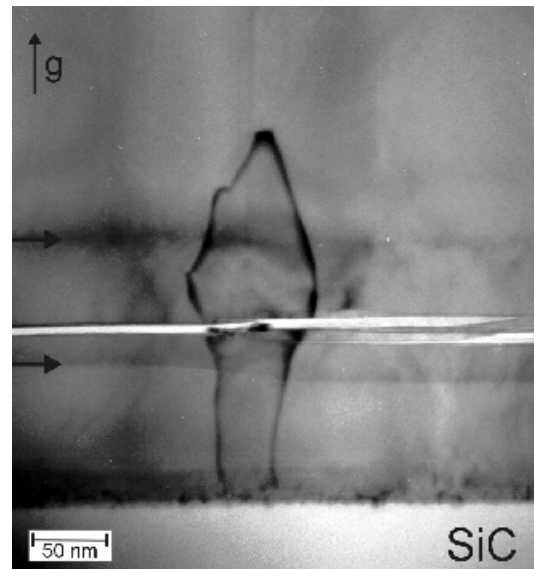
FIG. 3. Severe crack in a laser structure parallel to the (0001) plane. It clearly does not run along a heterointerface two of which are visible (marked by arrows). A dislocation is steadily passing the crack.
