## Fractographic Analysis of Co-P-SiC Electrocomposite Coatings by Stereoscopic Reconstruction

Sriram Vijayan<sup>1</sup>, Amit Datta<sup>2</sup>, John. D. Carpenter<sup>2</sup>, Mark Aindow<sup>1</sup>

<sup>1</sup>Department of Materials Science & Engineering, Institute of Materials Science, University of Connecticut, 97 North Eagleville Road, Storrs, CT 06269-3136

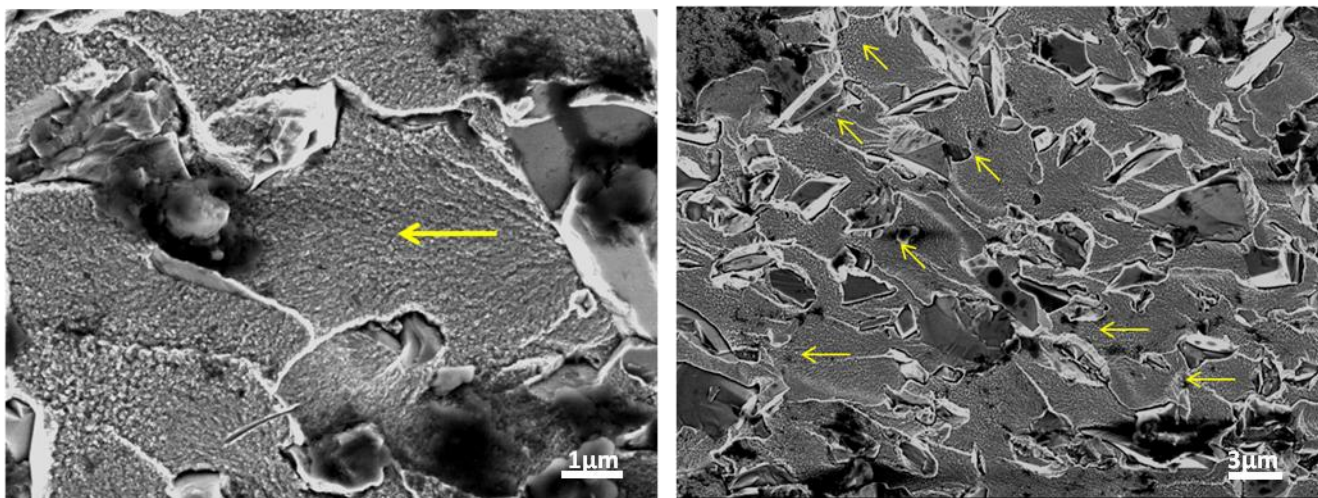
Initial SEM observations (e.g. Fig. 1) suggested three possible mechanisms for crack initiation: 1) cracks forming due to de-bonding at the matrix-particle interface; 2) fracturing of SiC particles due to cyclic loading; and 3) both of these processes occurring simultaneously. Stereoscopic SEM imaging was used to better reveal the topographic details of the fracture surfaces. Figure 2 is an example of a 3D reconstruction produced using the MEX software package from a stereo pair of SEM images. The topographic features in such reconstructions were related to the distribution of the SiC reinforcements by acquiring elemental X-ray maps from the same regions. An example of these data is shown in Figure 3, wherein the Si map reveals the location of the SiC within the Co-P matrix. The main conclusion of these observations is that crack initiation in these electrocomposite coatings occurs primarily at the Co-P matrix / SiC particle interfaces within the coating. These cracks then propagate towards the coating/substrate interface and into the substrate.

Figure 1: Secondary electron SEM images showing: (left) crack initiation; (right) crack propagation.

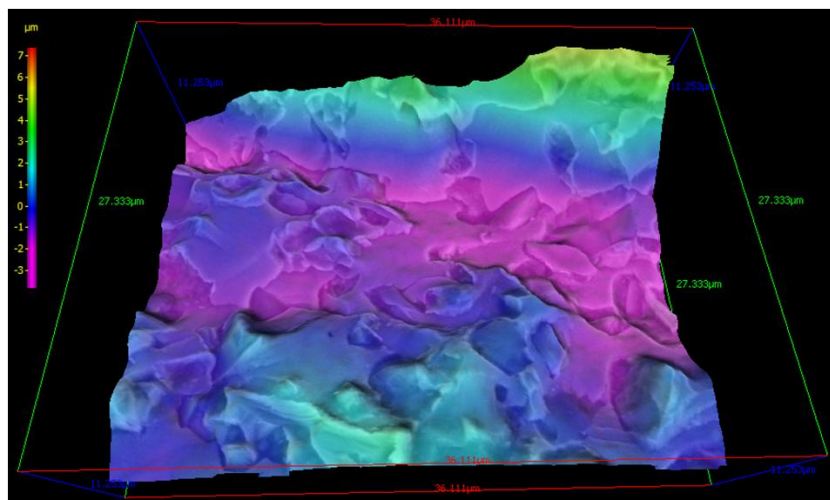
Figure 2: 3D reconstruction of a fracture surface produced using the MEX software

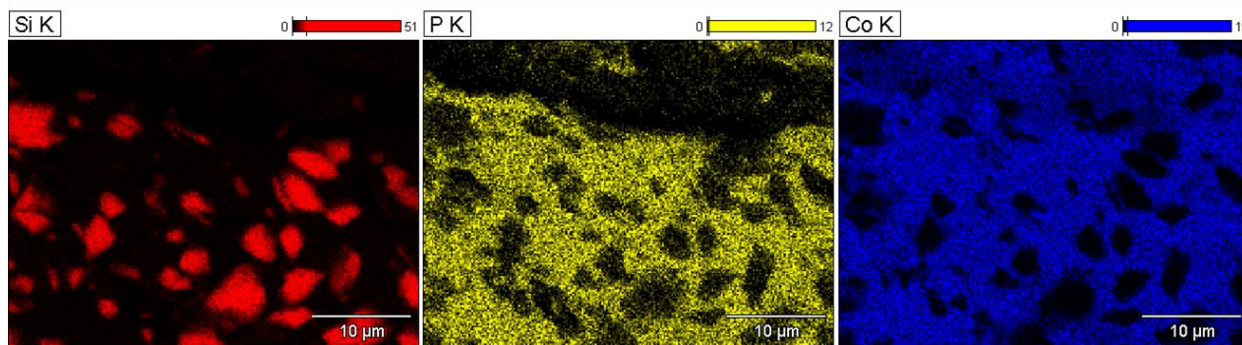
Figure 3: Elemental maps obtained from a fracture surface revealing the location of the SiC particles.
