Failure Analysis of a Ruptured Cast Aluminum Alloy Fire Hose Manifold

Shari Nathanson Rosenbloom¹, David Crowe, Ph.D.² and Karen Hessler³

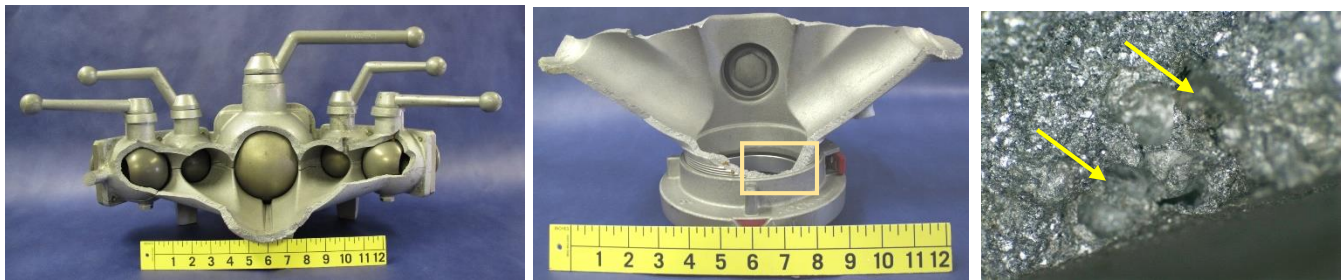
The manifold ruptured into two large pieces, Figure 1. Cracking was present all around the part and was roughly flush with the threads at the threaded inlet connection. To the unaided eye, the fracture surface appeared reasonably uniform. However, using oblique lighting and stereomicroscopy, casting voids were revealed near the inlet connection. In places, there was a white substance in the voids, Figure 2. As-cut and polished cross-sections at this location showed that the voids spanned a significant percentage of the wall, thus reducing the effective wall thickness. Prior to polishing, the white substance was analyzed by energy dispersive x-ray spectroscopy (EDS) in the scanning electron microscope (SEM). It was consistent with slag from the casting process.

The hose manifold ruptured when a brittle fracture propagated through the material. Several factors contributed to the failure. Numerous casting voids were present within the part, some of which contained a substance consistent with slag. These factors point to poor manufacturing control during casting. The microstructure was typical of an unmodified aluminum-silicon casting alloy and contained long, brittle, needle-like intermetallic phases. This microstructure does not impart good fracture toughness properties to the material. These factors – the voids which reduced the effective wall thickness and the brittle needle-like second intermetallic phases within the microstructure – allowed fracture to occur at lower stresses than would normally be anticipated for the casting. Once initiated, the crack propagated rapidly through the brittle material.

Figure 1. Several views of the ruptured hose manifold. Box in middle photograph shows location of right photograph as well as photographs in Figure 2. Right photograph shows voids in casting wall (arrows).

Better process control to minimize voids and slag within the casting would help improve properties. In

addition, aluminum casting alloy A356 reportedly has better fracture toughness than alloy 356. It contains less iron, which reduces the presence of brittle second phases. Also, microstructural modification through the addition of chemical modifiers and control over solidification rates can help to improve fracture toughness by refining the morphology of second phases within the alloy [2]. These measures are routinely employed in aluminum castings to produce alloys with more desirable mechanical properties.

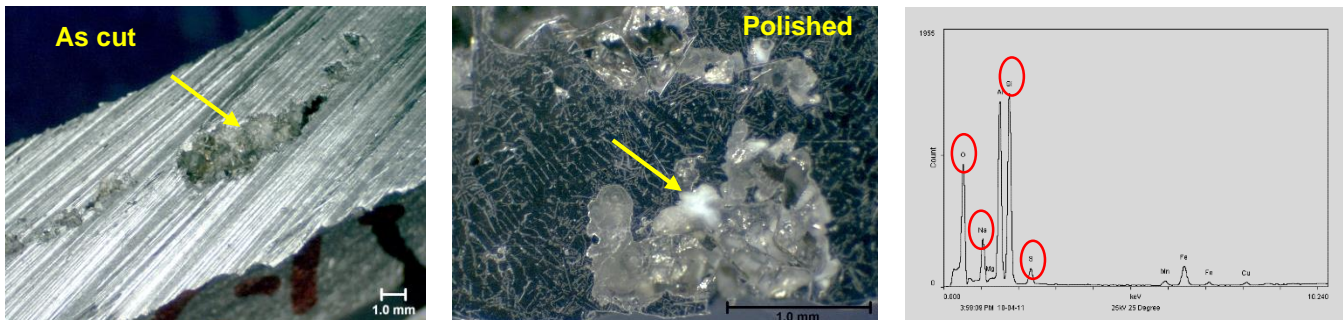
Figure 2. Large voids were present in the casting wall near the threads at the manifold inlet. Material within the voids (arrows) was high in silicon, sodium, oxygen and sulfur, as determined by EDS (right).

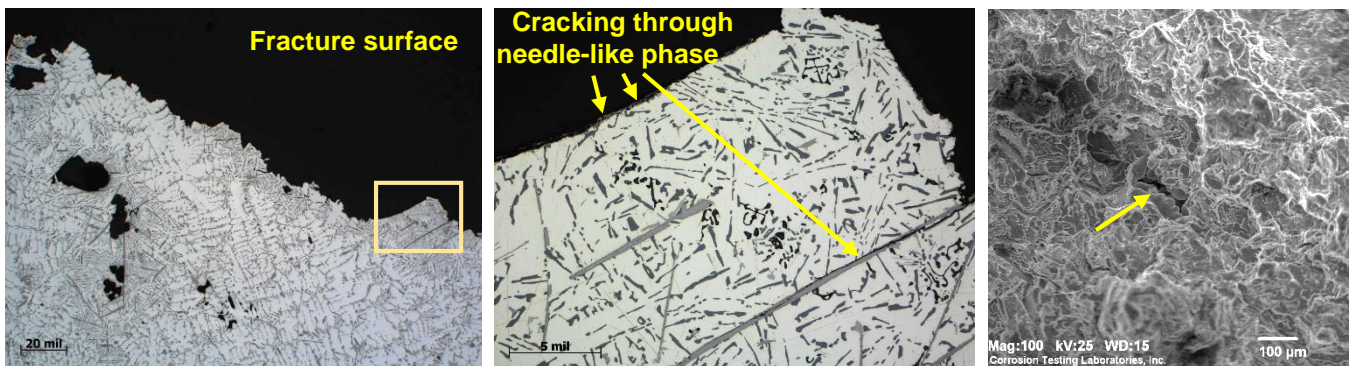
A cross-sectional metallurgical mount was prepared through the fracture surface, Figure 3. The microstructure consisted of aluminum dendrites with angular second phases of silicon and intermetallic phases of iron and magnesium. These phases are brittle and the cross-section showed evidence of cracking through them, especially at the long needle-like particles. This is consistent with the overall morphology of the fracture surface as revealed by SEM, which showed brittle fracture plus casting voids.

Figure 3. Cross-sections show voids near the fracture surface as well as an unrefined cast microstructure containing needle-like brittle intermetallic particles, through which cracking propagated (arrows). Box shows location of middle photo. SEM imaging reveals typical brittle fracture, plus casting voids (arrow).
