# Microscopic Analysis of Metal Recovered from the Wreck of RMS Titanic

J.J. Hooper McCarty<sup>1</sup> and T. Foecke<sup>1,2</sup>
<sup>1</sup>Department of Materials Science and Engineering, The Johns
Hopkins University, Baltimore, MD
<sup>2</sup> Metallurgy Division, National Institute of Standards and
Technology, Gaithersburg, MD
tfoecke@nist.gov

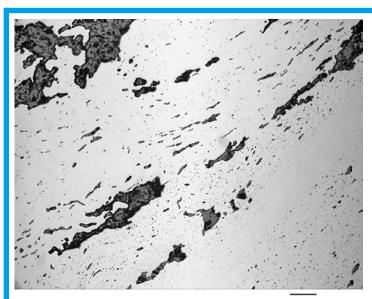
Figure 3: Optical micrographs of Titanic wrought iron indicate considerable variability in the microstructure among rivets. In this micrograph, large slag particles are seen to follow the direction of flow during formation of the rivet head. Bar =  $50\mu m$

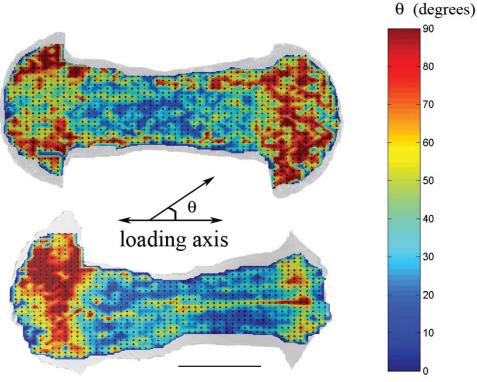
Image analysis revealed that in the heads of the rivets, which were hammered in place, slag is oriented perpendicular to the rivet shaft, or tensile axis. The slag particles run parallel to the rivet shaft due to extrusion while hot, which correlates with high tensile strength and ductility along the rivet shaft. Microscopy also revealed unbroken slag stringers in the rivet heads running perpendicular to the shaft, confirming that the heads were also formed while the rivet was hot. Note in Figure 3, how the slag within a Titanic rivet is oriented in a 90° turn, reflecting the effects of hammering a rivet head in place. This corresponds to what we know about early 20<sup>th</sup> century riveting procedures, where a rivet was driven and a head was hammered in place while still hot. (polished 100x image) Figure 4 shows results of image analysis from thousands of images in the cross-sectional mosaics of two Titanic hull rivets, indicating that the reorientation of slag stringers, which was found in all rivets, occurs independently of composition. (color plot)

Figure 4: Image analysis of thousands of micrographs from various regions within the cross-section of two Titanic hull rivets shows the orientation of slag particles with respect to the rivet shaft. Note the high concentration of particles in the heads of the rivets oriented at 90° (red) to the loading axis. Bar represents 1 inch (2.54 cm).

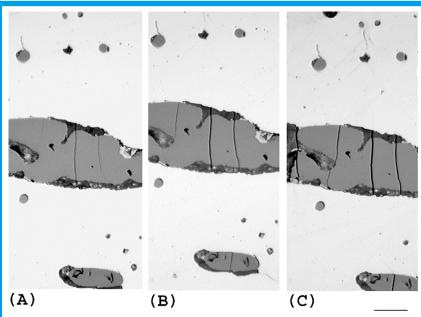
Figure 5. Optical micrographs showing the deformation of a slag particle in wrought iron when loaded along the extrusion direction. (a) At a total strain of 1.5% (b) 2.4% and (c) 3.8%. Bar represents  $20\mu m$ .

approximately 1.5% increments. (a) With little ductility introduced into the samples, fine cracks formed across large, elongated slag particles. (b) As the strain increased, the initial cracks penetrated across slag particles. Fine secondary cracks were initiated, further subdividing large slag particles into smaller segments. (c) Small, nearly undetectable cracks were observed emanating from the slag
