Microscopy and Elemental Analysis on a Haynes-25 Crushed Weld Ring

Angelique D Wall¹, Terry G. Holesinger¹, Joseph P.M. Romero¹, Ted F. Cousins², William L. Stellwag Jr.², Joshua Phillips³ and Andrew Sandford³

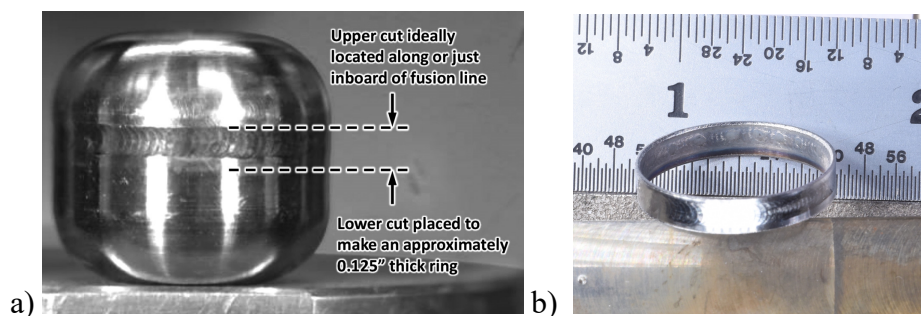
Figure 1. Optical images of (a) the fully assembled capsule and (b) a cross section through the capsule that contains the weld ring (images courtesy of Sandia National Laboratory).

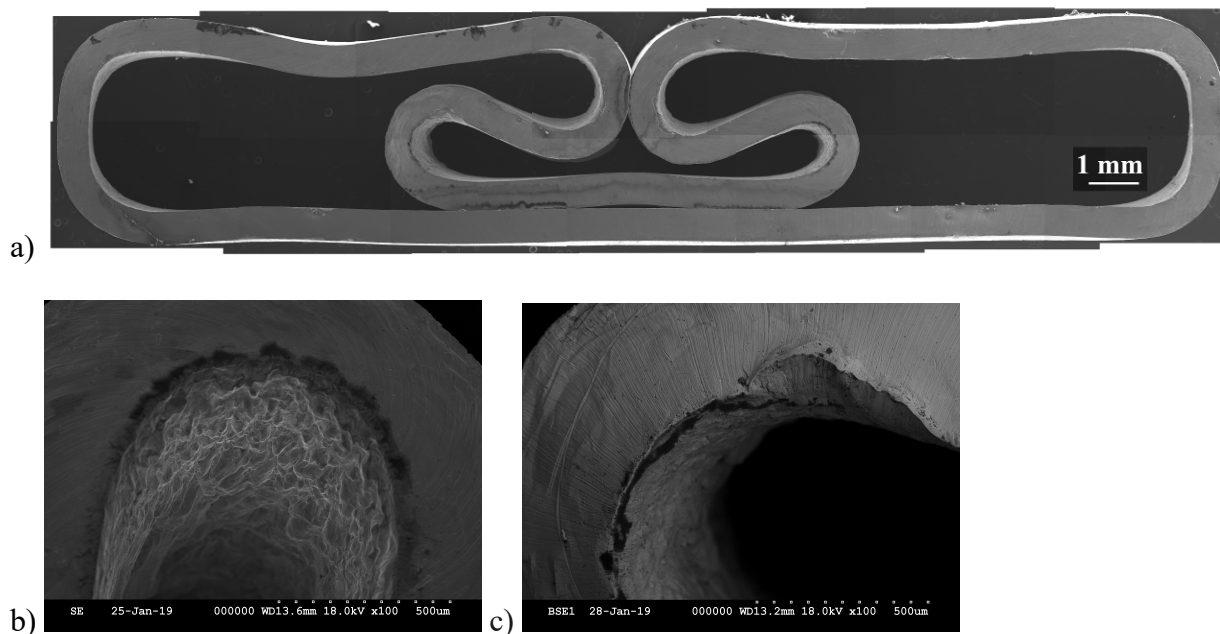
Confined crush tests were conducted by removing rings using a slow speed Isomet diamond saw near the edge of the weld at a width of 0.125 inches (3.175 mm), see Figure 1. The rings were ground using 400 grit sanding paper to improve inspections of samples for tears and cracks. The samples were crushed using a fixture in a vise to a height of approximately 0.130 inches (3.3 mm). No visual cracking was observed on any inner, outer, or edge surface. The crushed ring was then analyzed using a Hitachi S3500N Scanning Electron Microscope (SEM) to determine if there were any cracks or other observable damage to the crushed ring. The crushed ring was mounted on an aluminum stub using carbon tape with one of the cut sides facing up. After analysis on one side of the cut the crushed ring was rotated to image the second side, see Figure 2 a). SEM analysis confirmed that there were no cracks on the crushed rings. Secondary (SEI) and Back Scattered Electron Images (BSEI) were taken on both sides of the weld ring, see Figure 2 b) and c). Elemental analysis was also performed by energy dispersive spectroscopy (EDS) on the crushed rings using an Oxford Instruments X-Max 50 Silicon Drift Detector (SDD). No unexpected elements were found, but inspection of the weld region was made difficult by the geometry of the crushed ring. To further investigate, weld sections were cut out of rings and mounted in epoxy and polished for further analysis via metallography, SEM imaging and elemental analysis with the EDS system [4].

Figure 2. a) Crushed ring via stitched SEM images; b) Secondary Electron Image of the interior of the bends of the crushed ring. c) Back Scattered Electron Image of one of the interior of one of the bends of the crushed ring.
