Microscopy Investigation of Surface Contamination Effect on Fatigue Fracture of Al60 (Glidcop) Wire

RE Goddard^{1*} and VJ Toplosky¹

^{1.} National High Magnetic Field Laboratory, Florida State University, Tallahassee, FL, USA. *Corresponding author: goddard@magnet.fsu.edu

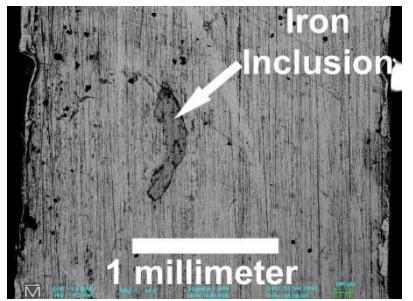
While spooling 5.2 mm X 8.6 mm Al60 conductor wire prior to magnet winding, inclusions were noticed embedded into the wire's surface (Fig. 1). Foreign particles, especially in the interior, can be detrimental to the performance of the wire under stress. Premature fatigue crack initiation may develop due to persistent slip bands radiating from a stress concentration [2]. To determine the effect, if any, of the surface impurities, fatigue tests were conducted and the fracture surfaces were analyzed [3]. Fatigue test samples were machined from the lengths of conductor that contained the inclusions. Eight samples with a reduced cross section (2.5 mm X 5.2 mm) were tested (Fig. 2).

Figure 1. Embedded surface inclusion (SEM Micrograph).

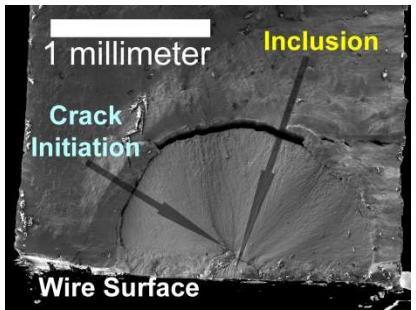
Figure 3. Fatigue fracture surface (SEM micrograph).

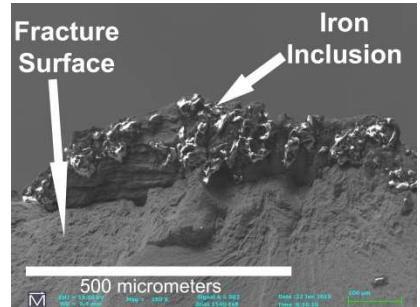
Figure 5. Inclusion view from fracture surface (SEM micrograph).

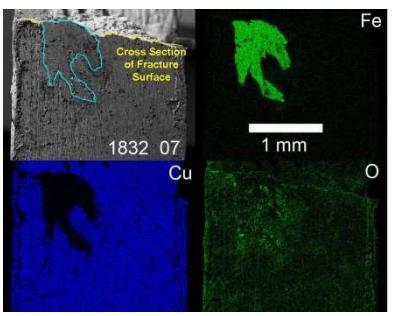
Figure 4. Elemental x-ray map of wire with surface inclusion.

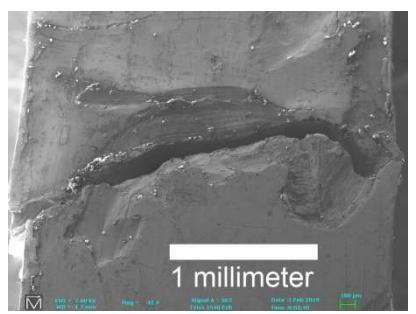
Figure 6. Fatigue fracture bisecting void left by inclusion (SEM micrograph).
