## **Metallography as a Microanalysis Tool during the Failure Investigation of the Starboard Solar Alpha Rotary Joint of the International Space Station**

V.S. Long,\* M.C. Wright,\* S.J. McDanel,\* P.J. Marciniak,\* D.L. Lubas,\* and B.P. Tucker\*

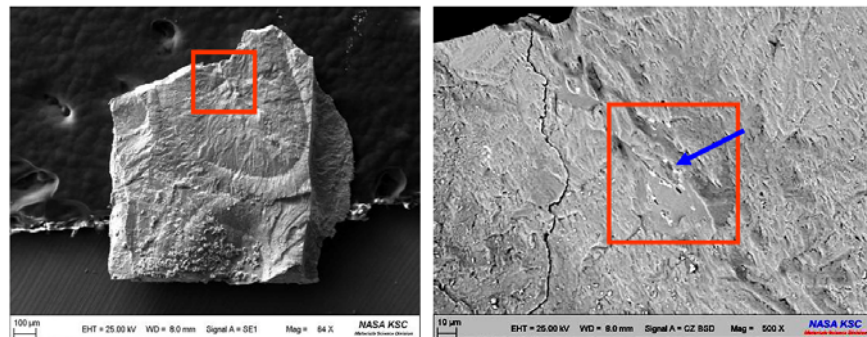
FIG. 1. SEM image of a fragment in secondary electron (SE) mode (left) and a higher magnification BSE image of the boxed area showing atomic contrast (right). This area appears to be the fracture initiation site and the elliptical feature suggests crack arresting. The light constituent is primarily Nb, and the dark constituent is MnS (arrow). Original magnifications: 54X (left), 500X (right).

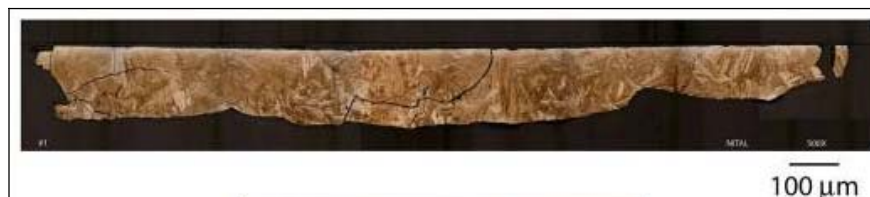
FIG. 2. Nitrided 15-5 PH fragments cross sectioned and etched to reveal the case layer microstructure and transgranular secondary microcracking. No martensitic core microstructure or case-core interface was observed. Etchant: diluted nital. Original magnification: 100X
