## Fresco Paintings Deterioration: Case Study of Bodjani Monastery, Serbia

Snežana Vučetić<sup>1</sup>, Jonjaua Ranogajec<sup>1</sup>, Slavica Vujović<sup>2</sup>, Snežana Pašalić<sup>3</sup>, John Milan van der Bergh<sup>1</sup>, Bojan Miljević<sup>1</sup>

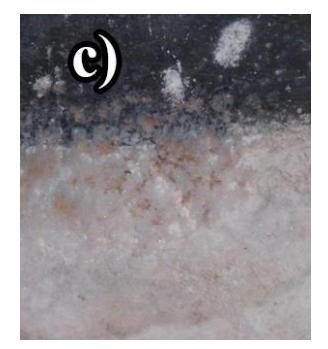
The Monastery lies in moderate continental climatic conditions on clayey and sandy soil. The Monastery is at risk as it is situated close to the Danube River, on soil greatly affected by underground water. Constant humidity and the consequent crystallization of salts on the painted surfaces are the main reasons for flaking and pulverization of the painted layer (Figure 1), appearing mostly in the lower area up to a height of 3 m (10 ft.). The church had only the system of air isolation of the walls and since 1974 the system for active electro-osmosis was also installed. However, over the years, these systems were not maintained, which affected ongoing destruction of the walls and the painted layers. The monastery is still in operation today, but its maintenance is not adequate considering its significance.

**Figure 1.** The view of Hristofor Zhefarovich fresco painting in Bodjani Monastery: a) northern wall; b) pulverization and crumbling of fresco paintings; c) salt crystallization on the fresco paintings surface

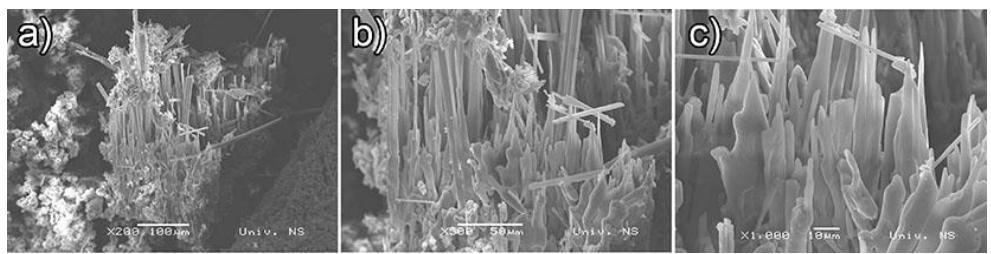
Based on the obtained results, presence of sodium sulfate was identified. Considering the environmental conditions on the sampling day (T =  $15^{\circ}C/59^{\circ}F$  and RH = 71%), it could be assumed that the stable phase which crystallizes is mirabilite, but SEM investigation showed that the morphology of the salt

crystals collected from the wall surface matches that of thenardite (Figure 2). Indoor brick samples collected from the same height below the fresco layer are ceramic products based on mineralogical forms: quartz, feldspar, calcite, mica and dolomite, originating from raw material mixture. There are collected two types of brick samples visibly different in their condition: ones are with good mechanical properties, while others are crumbling. The DTA/TG analysis confirmed that the crumbling brick samples were fired at a lower temperature – about 500°C/932°F, while the brick samples with good mechanical properties were fired below 800°C/1472°F, which explains difference in their state. The interval of pore radius (Hg porosimetry) and differences between mass % of Na<sup>+</sup> ions (EDS and IC) also explain the poor mechanical characteristics of the crumbling brick samples and visible salt crystallization on their surface as a consequence of structure destruction [2,3].

Figure 2. SEM images of salt crystals on the crumbling brick sample a) x200, b) x300 c) x1000.
