Journal of Radiotherapy in Practice

Technical Note

Evaluating dose uncertainty that is caused by excess CBCT frames on Elekta XVI systems using log file analysis – technical note

¹Singleton Hospital, Swansea Bay University Health Board, Swansea, Wales, UK and ²Health Education and Improvement Wales, Nantgarw, Wales, UK

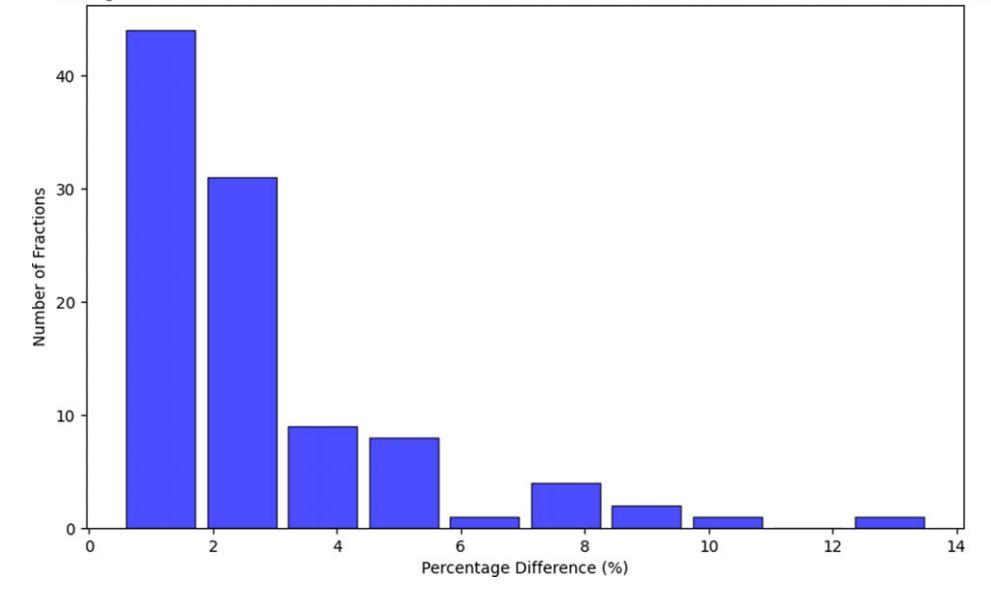
Figure 2 shows a histogram for the locally developed left breast protocol which has the highest occurrences of the frame error. A

noticeable factor to consider is that this is a fast protocol, meaning the gantry speed is 360 degrees per minute compared to 180 degrees per minute which is set for all non-breast protocols. The percentage range above the tolerance is 0.5 % to 13.6%. Between 0.5% and 2.5%, 53 fractions were captured, and between 2.5–4.5% there were 31 fractions. The left breast protocol preset alone has 101 entries, which is more than the total number of entries for all presets combined on each linac without fast protocols enabled.

Figure 2. Histogram showing the number of affected fractions for each frame percentage difference group for the Breast linac Left Breast Fast S20 preset.

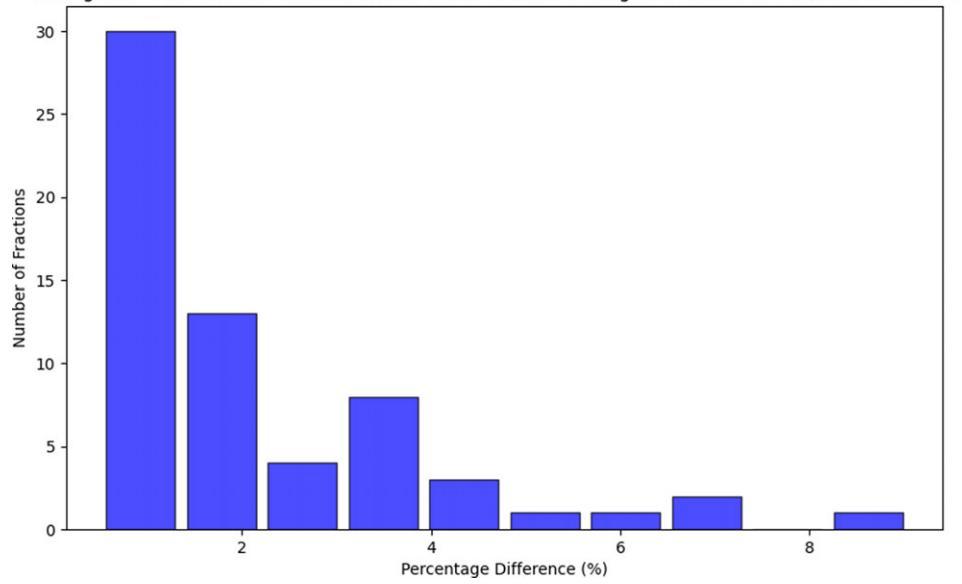
Figure 3 shows a fast breast preset for the right side for comparison to the left shown in Figure 2. The percentage difference ranges between 0.5% and 9.1% and there are noticeably less entries, 63 in comparison to 101 in Figure 2. The left breast technique uses the DIBH technique to reduce dose to the heart in comparison to the right breast technique.

Figure 3. Histogram showing the number of affected fractions for each frame percentage difference group for the breast linac Right Breast Fast S20 preset.

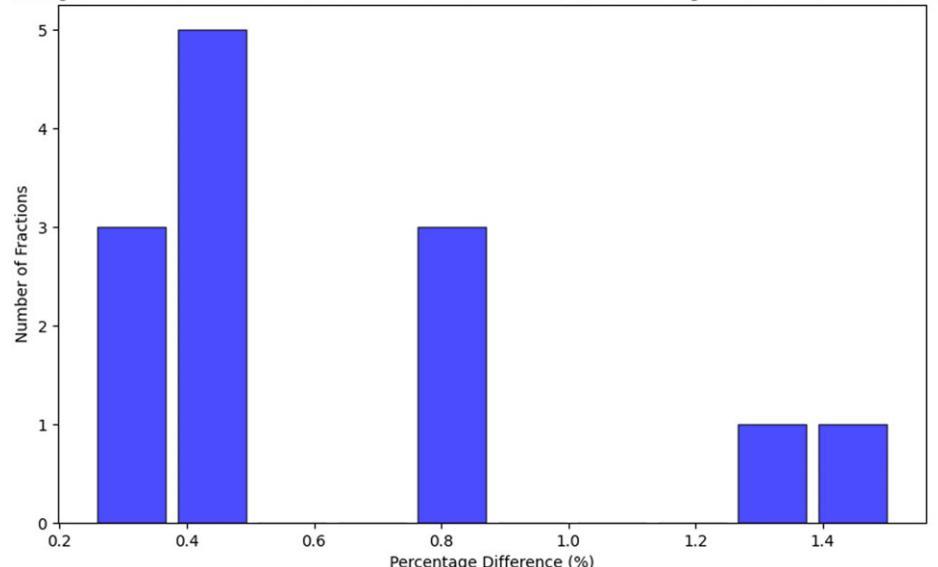
Figure 4 shows 13 entries for the 'Chest S10 Right Side CW' protocol. The percentage difference ranges between 0.3% and 1.5%. As previous figures show, most entries here are marginally above the Elekta tolerance where most in Figure 4 are under 0.9%. Although it's only just above the tolerance, cumulatively across each linac, this is a consistent occurrence.

Figure 4. Histogram showing the number of affected fractions for each frame percentage difference group for the breast linac Chest S10 Right Side CW preset.
