## **Study of Groove Formation in InP Surface During Zn Diffusion**

<sup>1.</sup> SemiConductor Devices, Haifa, Israel

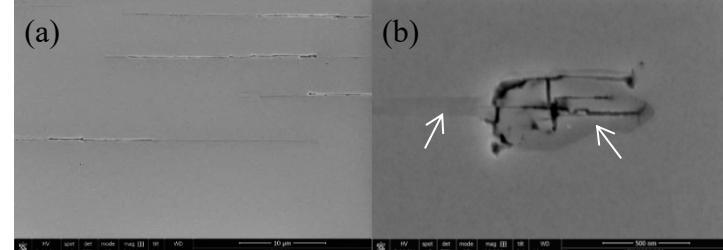
After diffusion, different widths and lengths of oriented grooves were observed on the degraded InP surface as shown in figure 1. FIB analysis combined with Energy Dispersive Spectroscopy (EDS) analysis revealed that the depth of these grooves is less than 0.3µm, i.e. they are present only in the InP layer. Their vicinity is enriched with Zn, the dark areas marked in figure 1(b). This phenomenon leads to an increase in the lateral diffusion and degradation of the photodiode performance. For the TEM microanalysis site-specific cross section lamella was prepared. The lamella was oriented perpendicular to the grooves and the challenge was to include a wide range of grooves with a variety of sizes on the same lamella. These sizes correspond to different stages of formation, from the initial stage to continued growth. The initial stage assisted in identifying the cause of its formation and the more advanced stage helped us determine its orientation and the processes that occurred with its growth. Figure 2 presents an example of the TEM lamella that includes 3 grooves at different stages of growth. The grooves are formed along the {111} crystal planes, see figure 2(a). Dislocation or any other related defects were not observed. EDS line scan of the marked line in figure 2(b) is presented in figure 2(c). Two amorphous layers are seen at the In P surface;  $Zn(PO_x)_v$  is the outer layer and the inner one adjacent to the In P crystal is Zinc Phosphide with a composition close to  $Zn_3P_2$ . The outer  $Zn(PO_x)_y$  layer is present thoughout the diffusion window and has a uniform thickness of 4nm, except for the area in which the groove starts to develop. The inner Zn<sub>3</sub>P<sub>2</sub> film does not have a defined thickness and length, and it depends on the groove size, see figure 2(a) and figure 3.

**Figure 1.** SEM images of typical grooves (a) low magnification and (b) higher magnification.

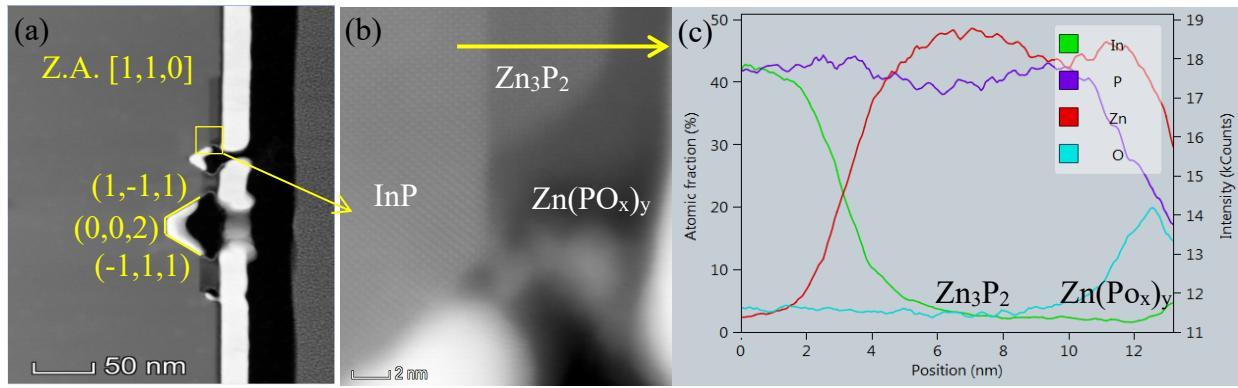
The  $In(PO_x)_y$  layer plays an important role in the degradation of the InP surface during Zn diffusion. Zn can replace In and react with P to form a  $Zn(PO_x)_y$  layer. We assume that the grooves are formed as a result of a stress relief mechanism. The formation and the growth of the  $Zn_3P_2$  layer are related to the grooves formation and subsequent growth. This layer grows and progresses with the groove.

**Figure 2.** STEM High-angle annular dark field (HAADF) images presenting grooves of different sizes, crystalline structure and composition. (a) Cross section of 3 grooves, (b) higher magnification of the highlighted area in figure (a) and (c) EDS line scan across the marked line in figure (b).

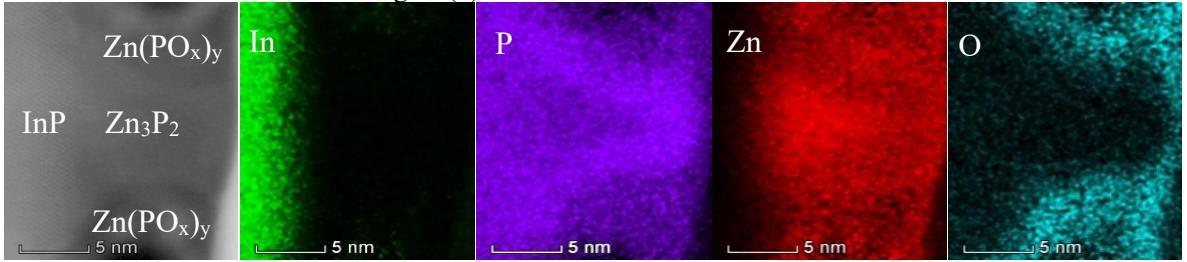
Figure 3. STEM HAADF image and EDS mapping analysis showing the structure and composition between 2 adjacent grooves.

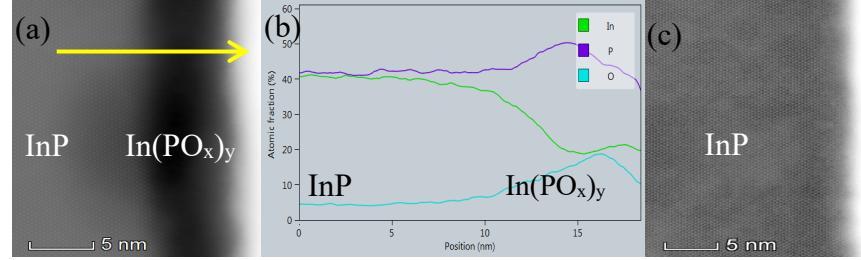
To understand the cause for the formation of these amorphous layers, TEM analysis was performed on wafers before diffusion. Figure 4(a) presents the TEM image of such a wafer and figure 4(b) the EDS line scan of the marked line in figure 4(a). The analysis reveals the formation of a thin amorphous layer of  $In(PO_x)_y$ , with a thickness of 4 nm, similar to that of  $Zn(PO_x)_y$ . The formation of this layer is related to the damage formed during the process for the diffusion window opening. By etching this layer [4] as presented in figure 4(c) surface degradation of the InP could be diminished.

**Figure 4.** STEM HAADF images and composition of InP layer (a) after the process for diffusion window opening, (b) EDS line scan across the marked line in figure (a) and (c) after etching.
