# Destruction and resilience at Panaztepe: archaeoseismological evidence for third-millennium BC earthquakes in Western Anatolia

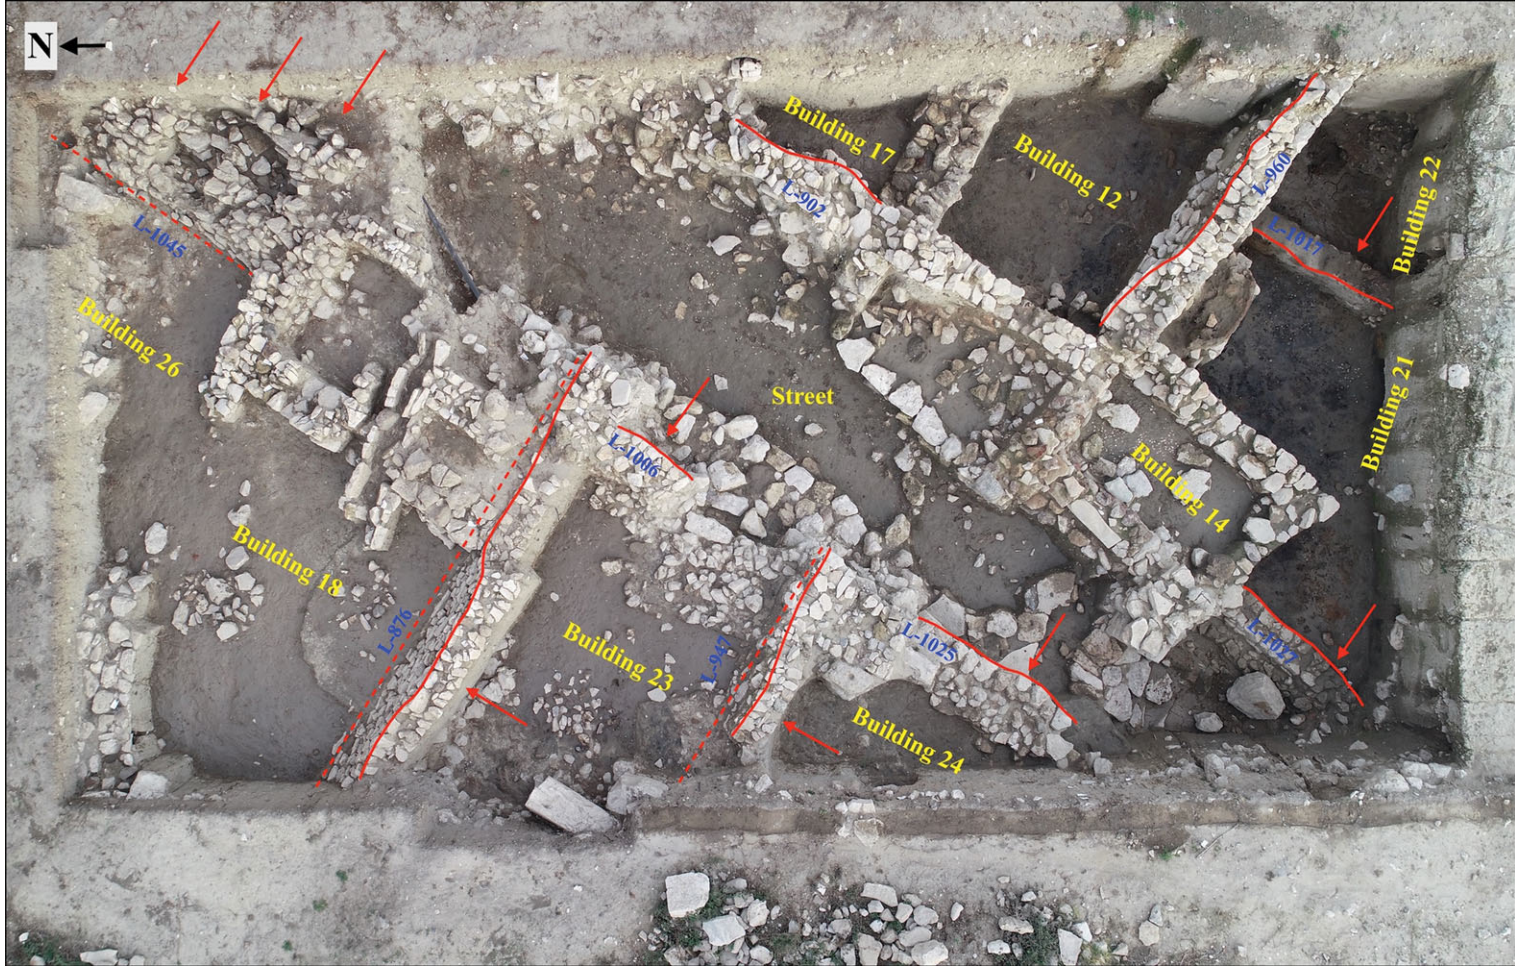
Figure 4. Aerial view of the Panaztepe Early Bronze Age settlement showing earthquake-related wall deformation patterns (figure by authors).

Building 23, located immediately south of and sharing the L-876 wall with building 18, also exhibits similar signs of destruction. During the earthquake, the L-876 wall deviated from its position and tilted approximately 40° to the south (Figures 7 & 8). This caused the mudbrick blocks at the top to collapse into the interior of building 23. The dense mudbrick debris found in both houses is direct evidence of the earthquake. The south wall of building 23 (L-947) is also tilted towards the south, and the wall opening onto the street (L-1006) exhibits lateral undulation deformation, with the rows of stones partially shifted towards the east. Therefore, traces of earthquake-induced destruction are clearly visible on three of the structure's walls. The collapse of the side walls affected the adjacent structures, causing deformation to the two central walls and significantly increasing the effects of the destruction (Figures 4 & 8).

Building 17 is located at the northernmost end of the eastern block. A snake-type undulation is apparent in the wall facing the street, which contains the entrance doorway. During the earthquake, the wall not only bent in a lateral undulation, but also bulged inwards and outwards. Similar findings were observed in structure building 12, located south of building 17. The wall containing the street-side entrance door of this house bent during the earthquake, causing a directional shift in the stone masonry. The L-960 wall, located east of building 12, is a shared side wall with building 14. The stone foundation of this wall is thicker and more solidly built, but the dimensions decreased in the upper phase. During the earthquake, this wall underwent snake-type undulation deformation (Figures 4 & 9).

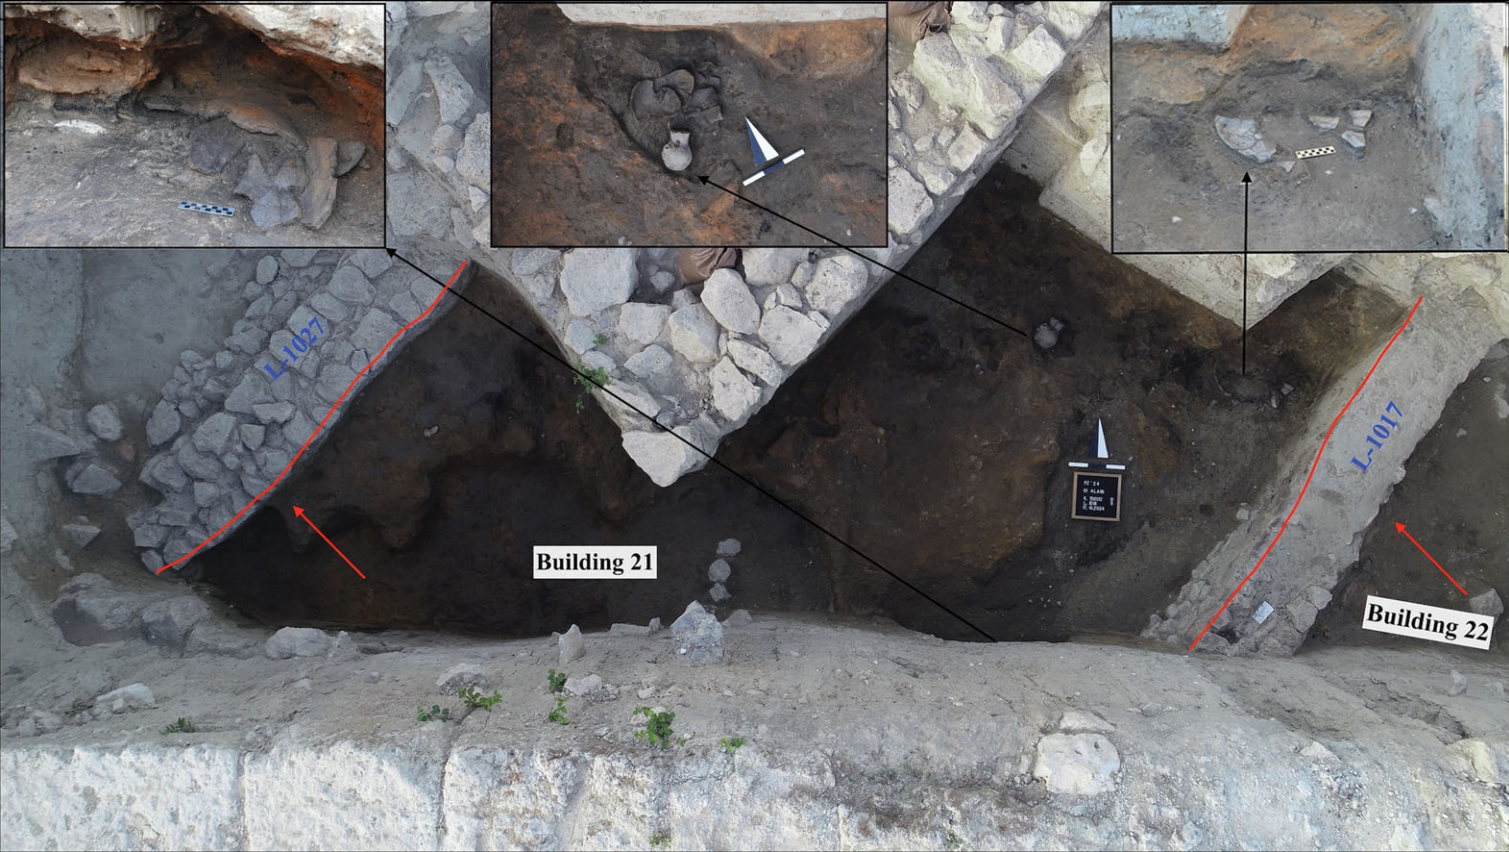
Figure 5. Snake-type undulation and eastward tilting of walls in buildings 21 and 22. The secondary effects of the earthquake are represented by the collapsed roof, the subsequent fire and the artefacts preserved in situ beneath the destruction layer (figure by authors).

burnt roof debris (Figure 5). These findings suggest that the building collapsed suddenly during the earthquake, leaving the inhabitants no time to collect their belongings as they evacuated. The evidence from building 21 illustrates a sequence of architectural destruction caused directly by an earthquake and ensuing fire.

Building 22 is located to the east of building 21 and shares the L-1017 wall. Although only part of the structure has been uncovered, the effects of the earthquake are observable. During the seismic event, the building's walls collapsed, and the roof fell into the interior, forming a substantial roof deposit. The subsequent fire exposed the roof to intense heat, turning it reddish-orange, and the roof remains were found to have burned en masse (Figures 5 & 6).

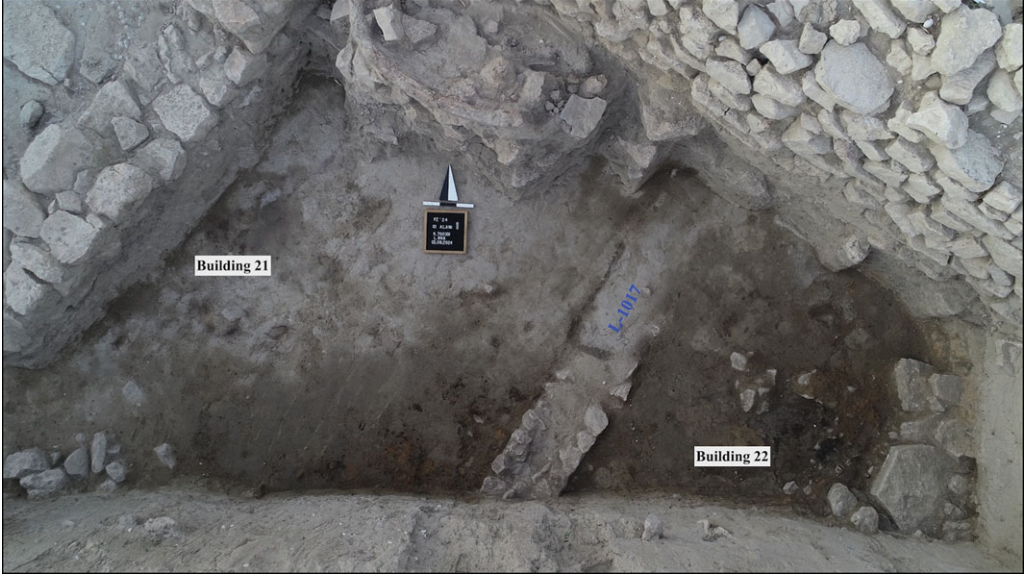
Figure 6. Eastward block collapse of the L-1027 mudbrick wall in building 21 (figure by authors).

Traces of the earliest earthquake activity to affect the Panaztepe settlement have been documented in two structures belonging to Phase I (c. 3000–2700/2650 BC; see Table S1). These structures, oriented along a north-east to south-west axis, represent the earliest occupation layer so far identified in the New Excavation Area. One of the structures associated with this phase, building 21, shares its L-1027 and L-1017 walls with adjacent buildings. The structure is approximately 4m wide, with 4.20m of its length excavated; the southern section could not be investigated, as it lies beneath Roman-period architectural remains. The primary effects of an earthquake are clearly documented in this building. During the seismic event, the two load-bearing side walls were subjected to substantial stress. The western wall (L-1027) developed a snake-type undulation and tilted slightly eastward; the stone foundation of the eastern wall (L-1017) exhibits a comparable snake-type undulation and eastward tilt (Figure 5). The roof of the building collapsed into the interior during the earthquake, after which the mud brick superstructure of the L-1027 wall fell as a block eastward onto the roof debris. The consistent eastward orientation of the tilting in both parallel load-bearing walls provides strong structural evidence for the directionality of ground motion, pointing to a coherent seismic impact rather than random structural failure (Figure 6).

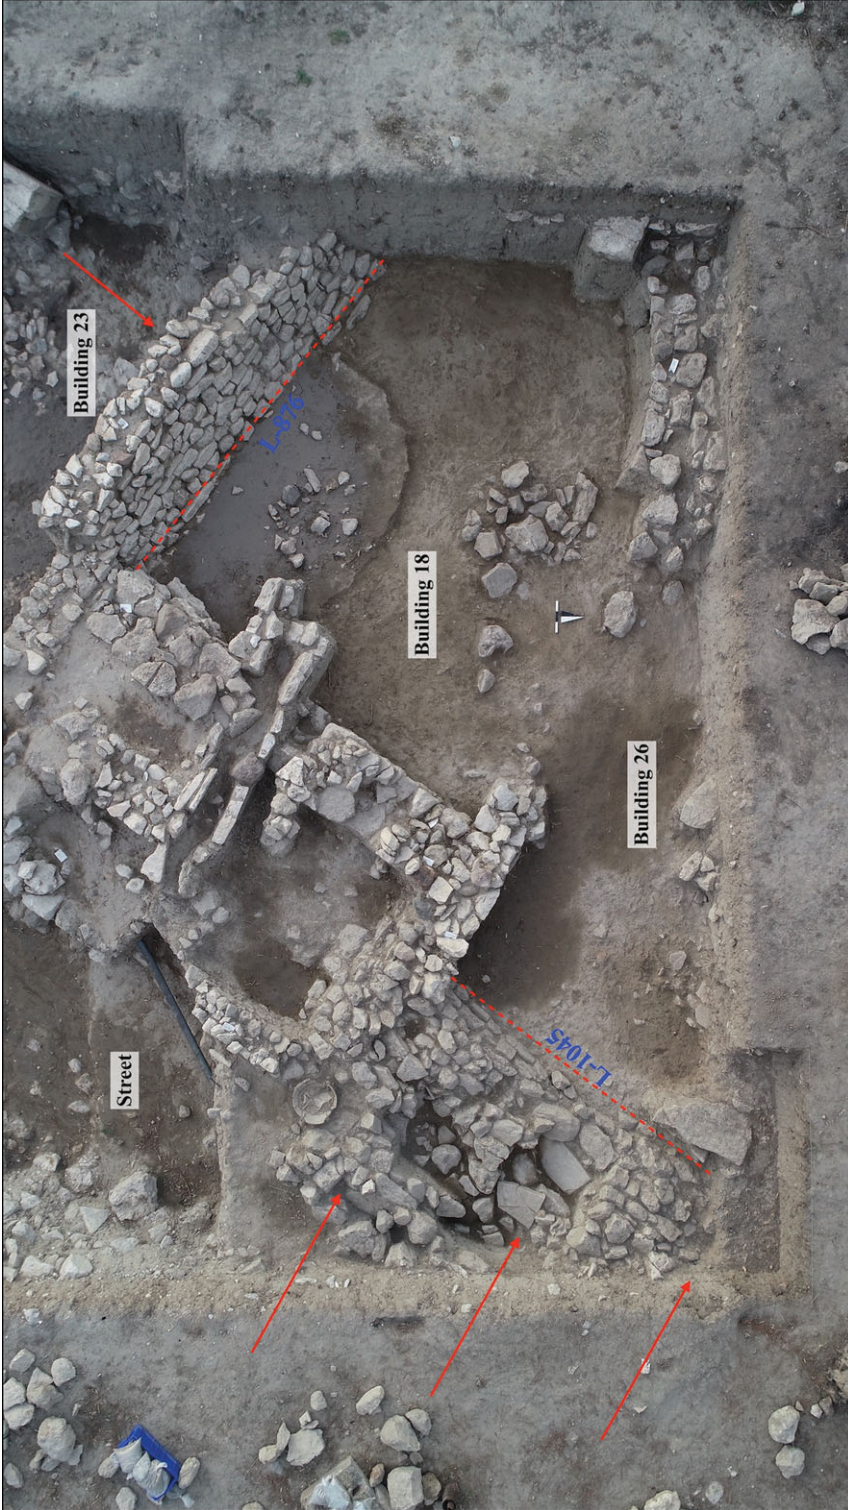
Figure 7. Eastward block collapse of the L-1045 wall and southward tilting of the L-876 wall in Phase III (figure by authors).

block. Under normal, non-seismic circumstances, debris from a collapsed wall would be expected to scatter to both sides; the stepped arrangement of the exposed stones and the fact that the wall fell as a single block over an area of approximately 2.5m demonstrate that the destruction was abrupt and directional. Block-wise wall collapses like this are generally attributed to seismic activity and are classified as one of the primary effects of earthquakes (Figures 3, 7 & 8).
