# Application of Advanced Back-Side Optical Techniques in ASICs

## Introduction

### First Investigation: Failure Within the Sea of Gates

### Second Investigation: Failure Within the Embedded Memory of an ASIC

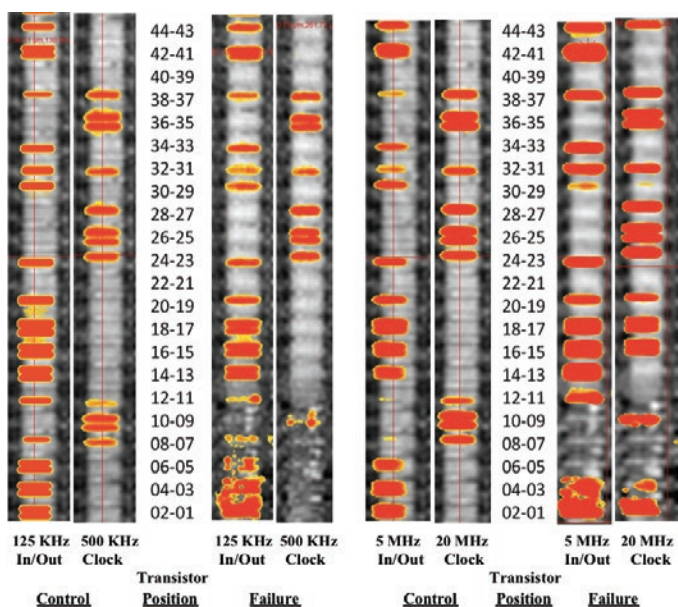
The flip-flop circuit that was observed on the front side using PEM overlapped the abnormal region on the back side. Because LVI was being performed, it was important to understand that the flip-flop circuit, in conjunction with the way that it was exercised by the digital tester, has a clock frequency that is 4× that of the input (or output) on/off frequency. To determine if the abnormal region was indeed a processing issue, LVI was used to check the functionality of the circuit at two different clock frequencies (500 kHz and 20 MHz). The frequency settings for LVI were 125 kHz/500 kHz and 5 MHz/20 MHz. The LVI images of the most active column of the flip-flop circuit were monitored, and a comparison between the failure and the control was performed (as shown in Figure 6). The LVI locations as shown by the transistor positions for the 125 KHz/500 KHz comparison are nearly identical except for the abnormal region. The 5 MHz/20 MHz LVI in Figure 6 show differences at other transistor positions outside the abnormal region, due to those transistors being downstream from the affected region.

Figure 6: LVI control/failure comparison at 125 KHz/500 KHz and 5 MHz/20 MHz (in-out/clock; frequency).

In hindsight, this example investigation illustrates that LVI is best used near the frequency threshold (as supported by data in Figure 4) when the device is passing, for frequency-related failures of this type. It also demonstrates that if an intermittent cannot be easily made to fail as interpreted by a digital tester, the deleterious effects can still be observed using LVI (PEM also).

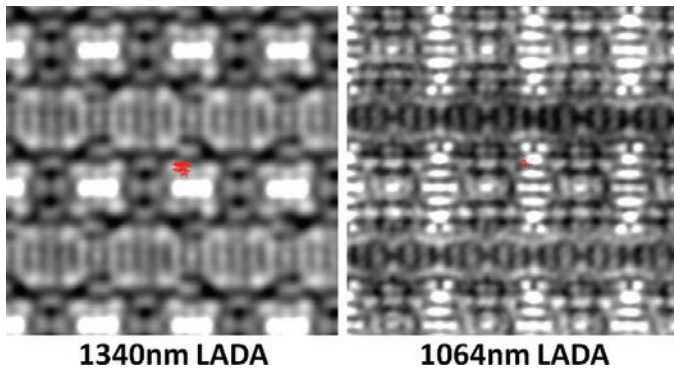
Figure 9 shows at least 12 embedded memory bitcells in each of the two laser-scanned images, which also include the

**Figure 9:** LADA shows the region that caused failure (red pixels) in the second IC investigation: 1340 nm laser (left) and 1064 nm laser (right).

failing bitcell in the center of the image. LADA demonstrated that both the 1340 nm and 1064 nm laser wavelengths could generate enough local heat to cause the failure to reoccur. LADA was *assisted* by digital tester feedback to give pass/fail status for every pixel in the laser-scanned image; a red pixel overlay in Figure 9 shows when failures were indicated. Because the surrounding bitcells had a passing status consistent with

the original fault signature, it was deemed that laser *alteration* demonstrated the fidelity required to replicate the failure in this fashion. LADA provided accurate localization of the failing transistor. Both images of Figure 9 have equivalent magnification and position.
