Localized surface-ice weakness on a glacial ice runway

ABSTRACT. Following construction of a glacial ice runway on the Ross Ice Shelf, Antarctica, and prior to flight operations, the runway was proof-rolled. The proof exercise was designed to simulate typical heavy aircraft. Initial testing produced numerous brittle surface failures in the runway ice. Thin sections of ice cores taken from the failed areas showed large crystals (*c* axis vertical) of clear, blue ice with long, vertical bubbles, indicative of ice formed directly from meltwater. Uniaxial unconfined compression tests on core samples were used to compare runway ice strength with published data for polycrystalline laboratory ice. Since the frequent failure of surface ice had not been expected, it was critical to understand the formation and mechanical properties of the weak ice to prevent its occurrence in the future and to strengthen the existing problem areas. We discuss the likely scenarios for development of weak ice on the airstrip and the physical properties of this type of ice. Also, the procedure used to repair successfully the runway surface is described, which culminated in test flights, followed by full fligh

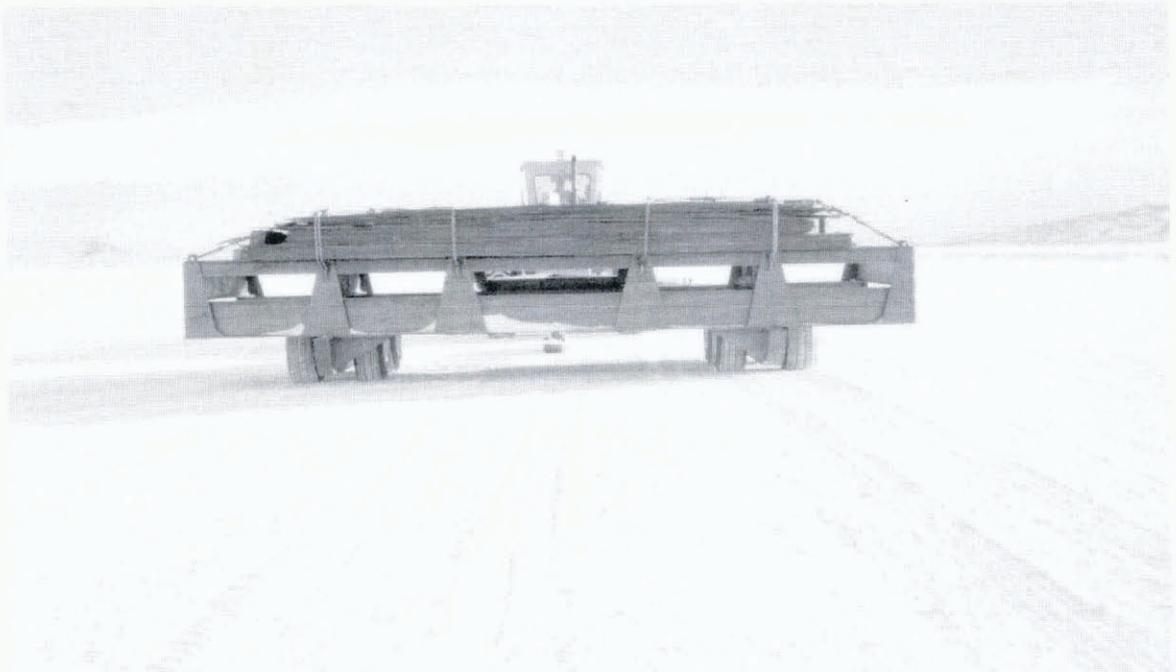
Fig. 1. Proof cart configured to simulate the main landing gear of a C-141 aircraft.

A proof cart was configured with eight C-141 wheels placed in the exact arrangement as in the main landing gear of a C-141 aircraft (Fig. 1). The cart was loaded with structural steel to the maximum C-141 main-gear load plus 18%. The maximum take-off weight of the C-141 is 1063 kN (5% of that load carried by the nose wheels) and the main gear tires operate at 1.38 MPa. During testing, the proof cart had a gross weight of 1192 kN with the tires inflated to 1.8 MPa.

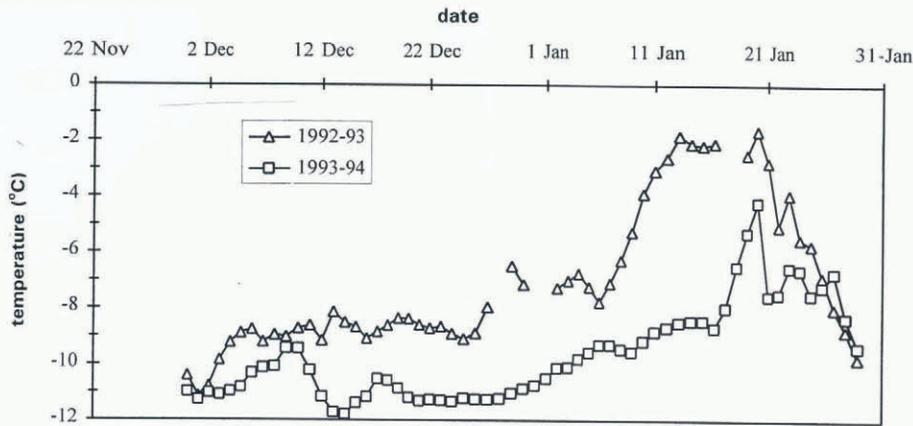
Fig. 2. Surface-ice temperature profile through time at the 1610 m marker on the Pegasus runway, austral summers 1992–93 and 1993–94.

The C-141 proof-rolling in November 1992 produced many near-surface failures in the runway ice. These failures were brittle; the ice shattered under the tires as the proof cart passed. Ice cores showed that the surface ice was not composed of the typical milky white glacial shelf ice that forms naturally from snow under compression, but instead it was clear blue ice with long, slender, vertical bubbles, indicative of ice formed directly from freezing water. During the 1990–91 austral summer, construction activities on the runway had caused localized surface melting as the protection of the snow cover was removed. Also, meltwater had been used to fill a large, natural depression between approximately 1200 m and 1800 m along the runway, in order to avoid lowering the entire runway surface to the minimum grade. Depths of this meltwater-derived ice ranged from a few centimeters to more than 1 m. Thin sections of this ice revealed large, vertically oriented crystals (c axis perpendicular to the ice surface), typical of lake ice. Every area of surface failure on the runway occurred in this “blue” ice. The ice temperature was less than -11°C at depths near the surface during November (Fig. 2).

The following austral summer, at the end of January 1994, the Pegasus runway was proof-rolled for C-141 loads with no ice failures. Ice temperatures during this period were less than -10°C (Fig. 2). On 7 February 1994, a fully successful C-141 flight test was performed.

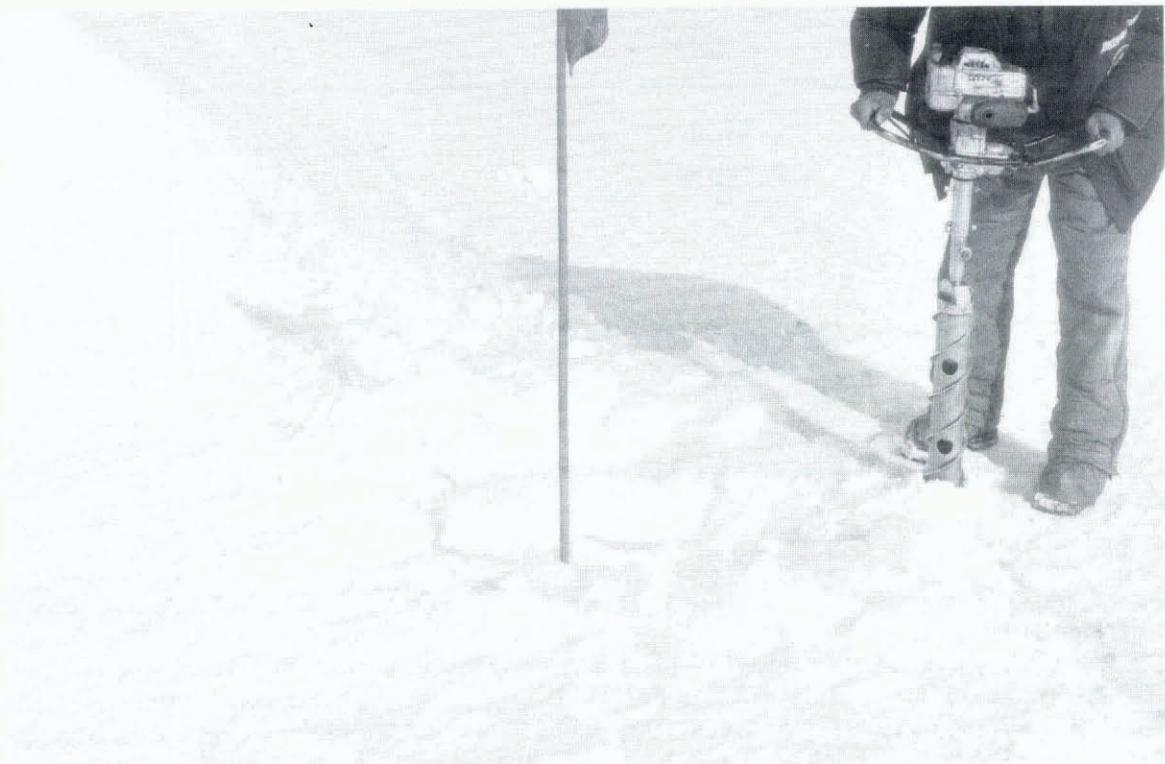
Fig. 3. Site of an ice failure caused during proof-rolling.

Only a slight perturbation of the proof cart was noticed when an ice failure occurred. We closely followed the cart during proof-rolling and noted that, when failure occurred, the ice seemed to suddenly turn to rubble in an area much larger than the contact area of a single tire (Fig. 3). In most cases, ice failure happened as a single rapid event and the proof cart quickly moved out of the crumbled area

(where it only experienced minor sinkage) on to adjacent ice where it was supported on the surface. Occasionally, the proof cart would generate progressive ice failures as it moved forward until it found sound ice again.

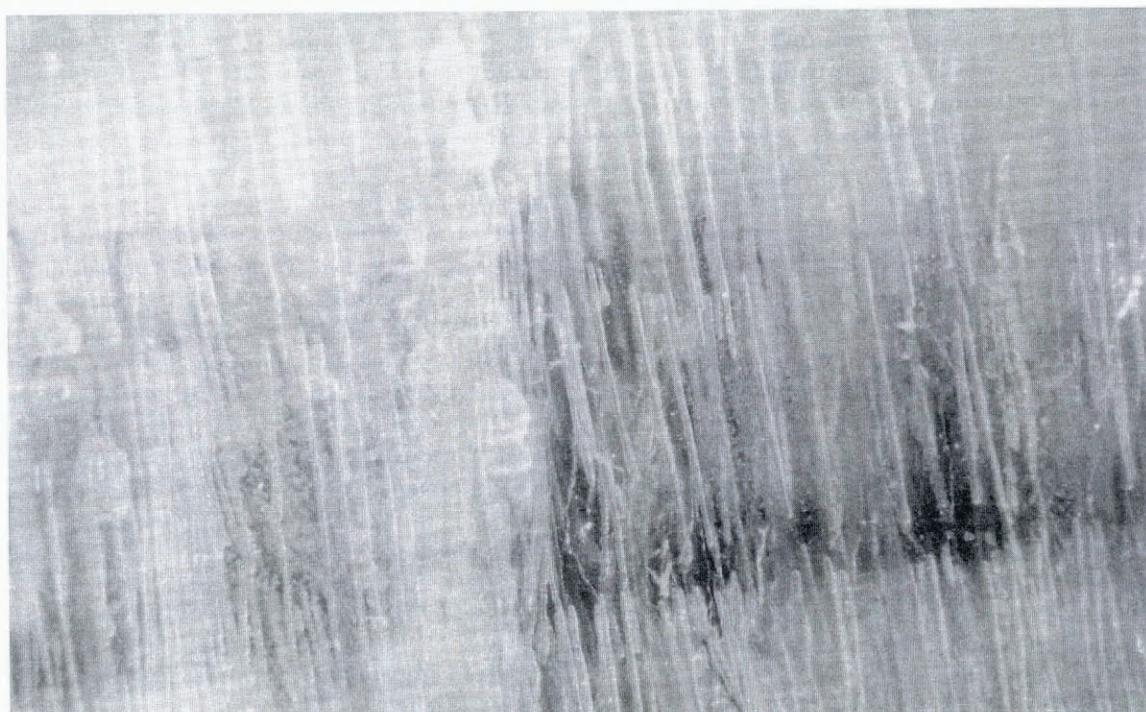
Fig. 4. Core sample of weak Pegasus runway surface ice.

We excavated the ice from failed areas and found that, macroscopically, most of the ice was very clear, contained many thin, elongated bubbles, and groups of these bubbles had a very distinct orientation (Fig. 4). Most

were vertical or nearly vertical. The ice exhibited concoidal, brittle fracture. Internal failure surfaces were revealed by reflected color bands. The depth of damaged ice ranged from a few centimeters to 1 m. Excavation of the failed areas revealed that the ice had been broken into 0.1–0.3 m diameter chunks. Chunk size seemed to be quite uniform throughout the failed area and failure planes were random. At the base of the failed area there was a distinct boundary, usually with an undulating surface. In some instances, the surface was steeply sloped. The surface had a mottled appearance and hoarfrost often coated the ice above this boundary. The ice below the boundary was always completely undamaged and was clearly glacial in origin (formed by accumulation and subsequent consolidation of snow). Occasionally, the boundary could be traced back under the sidewalls of the excavated cavity and it was clear that a thin gap was present between the lower glacial ice and the overlying clear ice. Hoarfrost was present in this gap.

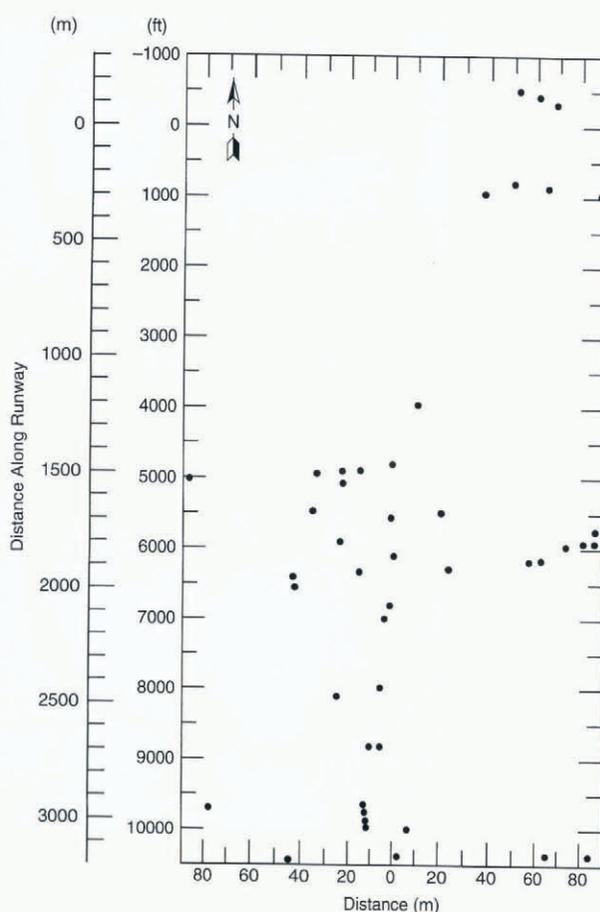
Fig. 5. Sketch of the Pegasus runway showing the location of surface-ice failure areas.

Most of the ice failures occurred between 1220 and 1830 m but failures also occurred, with lower frequency, near the 0 and 3050 m markers. A sketch of the runway and failed areas is shown in Figure 5.

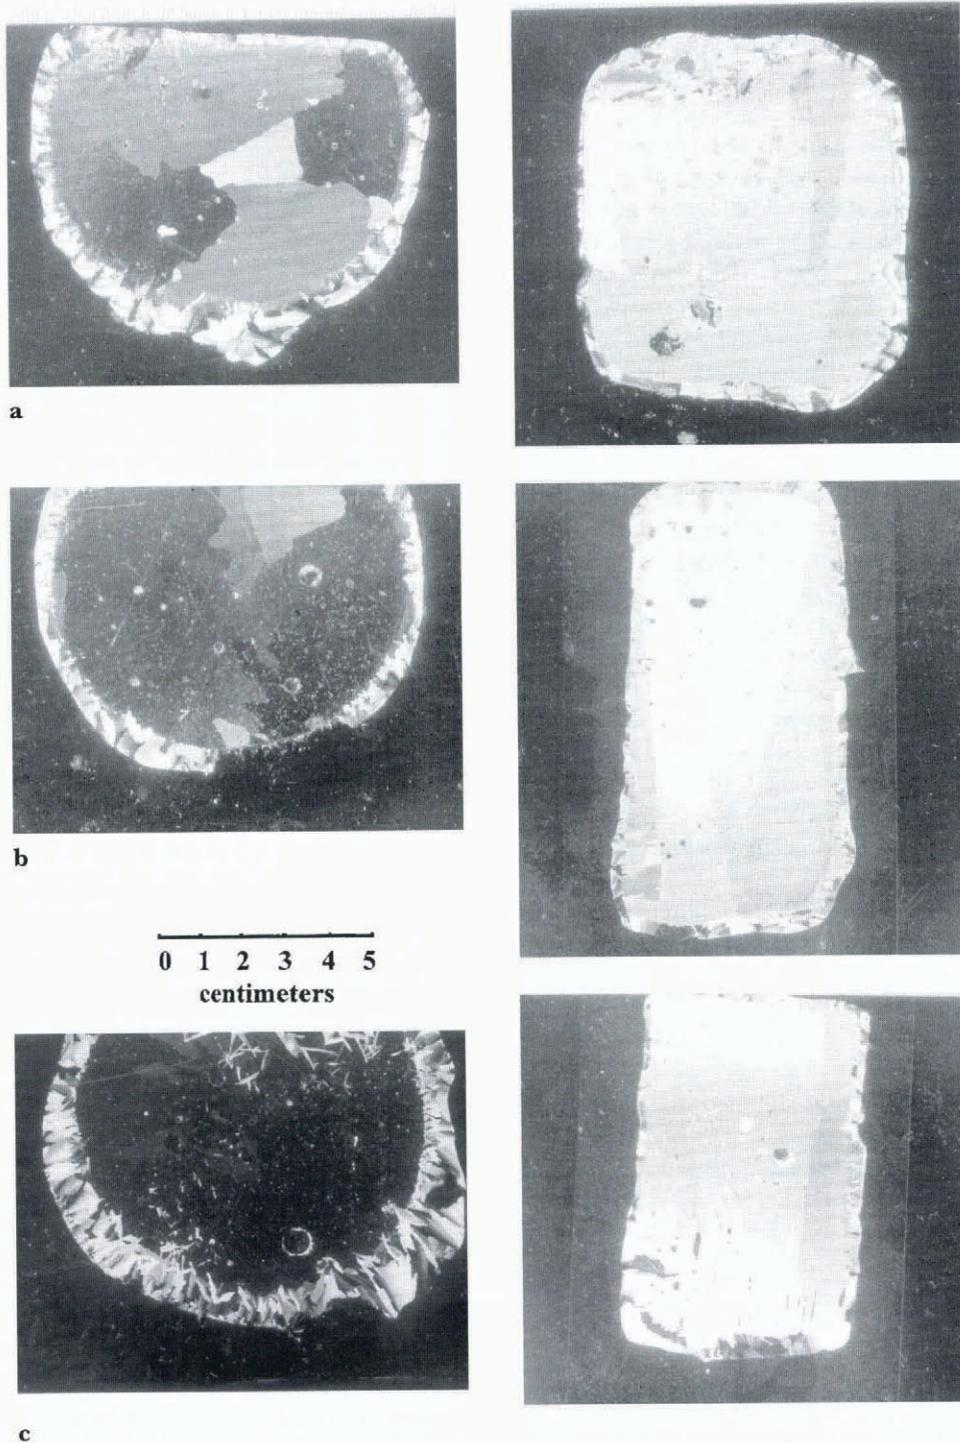
Fig. 6a-c. Horizontal (left) and vertical thin sections of core sample removed from the Pegasus runway surface at the 1830 m zone: a. 0-5 cm; b. 5-18 cm; c. 18-35.5 cm.

The number of inclusions decreases with depth as shown in Figure 6b and c. Between 18 and 35 cm depth, internal damage is apparent from the 2–7 mm radial cracks

seen in the horizontal section (Fig. 6c). Grain boundaries are not well defined and the grains are more elliptical, with jagged boundaries in the horizontal plane. Bubbles increase in size with depth. At 40 cm depth, a distinct boundary occurs, delineating the meltwater ice to glacial ice transition (Fig. 6d). From 40 to 68.5 cm (bottom of the core; Fig. 6d, e and f) the ice is characterized by 0.5–5 mm diameter, randomly oriented grains with some intrusion of melt at the boundary to a depth of approximately 45 cm. The ice grains in the snow-derived ice below the boundary increase in size with depth (Fig. 6e and f).

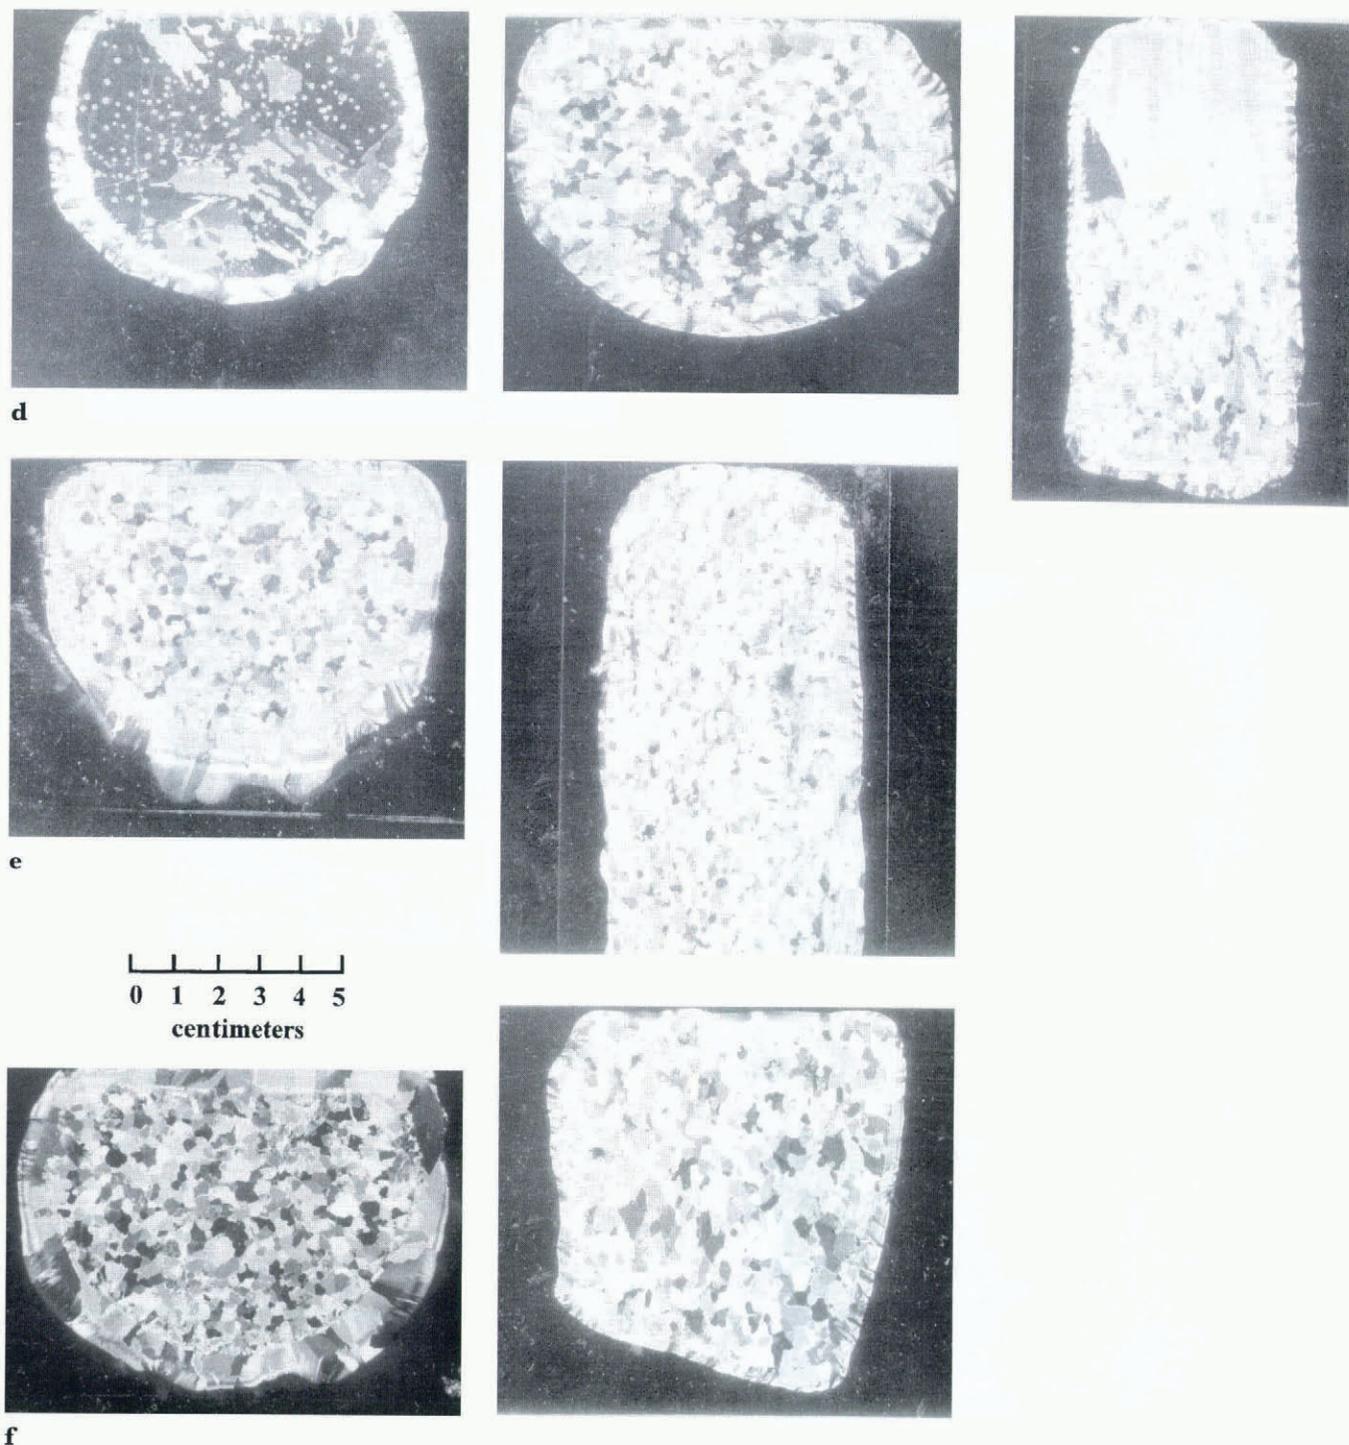
Fig. 6d-f. Horizontal and vertical thin sections of core sample removed from the Pegasus runway surface at the 1830 m zone: d. 35.5–49.5 cm; e. 49.5–63.5 cm; f. 63.5–68.5 cm.

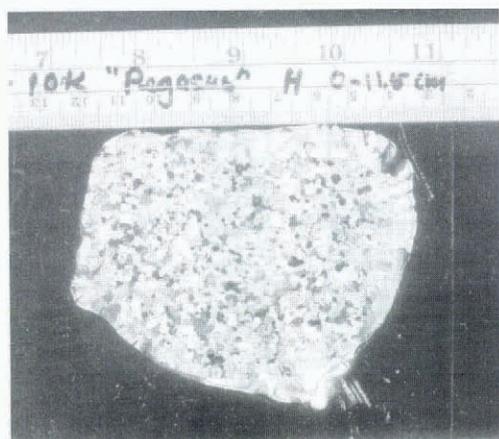
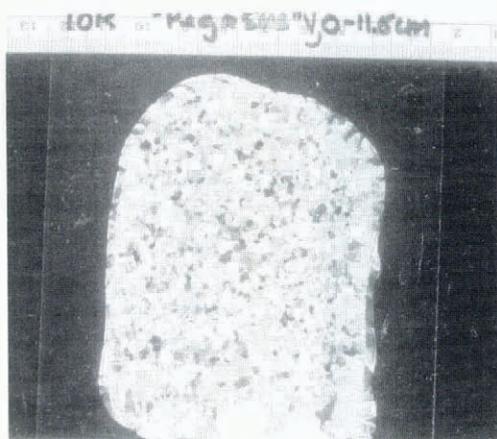
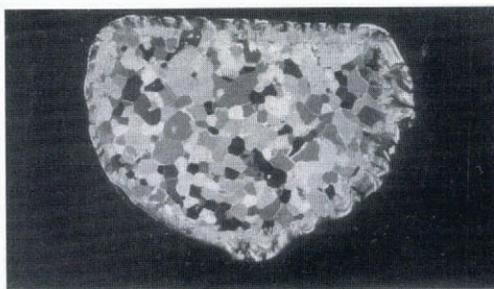
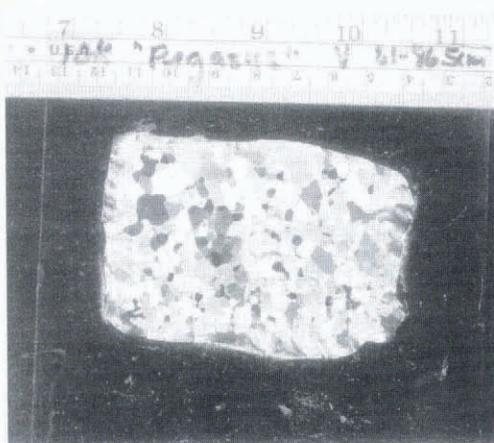
Fig. 7. Horizontal (top) and vertical thin sections of core sample removed from the Pegasus runway surface at the 3050 m zone (south end): a. 0–11.5 cm; b. 81–86.5 cm.

At the south end of the runway, the ice in the upper horizon (0–11.5 cm) is randomly oriented and grain-sizes range from less than 0.5 to 9 mm (Fig. 7a). This uppermost layer appears to be firm. Beginning at about 32–34 cm depth, the ice grain-size begins to increase and this increase is relatively linear to a depth of 81–86.5 cm. At the base of the core, the ice grains become more uniform and the average grain-size ranges from 5 to 10 mm (Fig. 7b). The origin of this ice also appears to be glacial but distinctly older, since crystals have coalesced to form larger grains. This core indicates that the south end of the runway perhaps had only small, localized areas of melt, as the thin sections do not reveal meltwater-derived ice. It is known from our own ice-temperature profiles at the north and south ends of the runway and the ambient temperature data from Automated Weather Stations located at both the north and south ends of the runway that typically the south end is 2°C cooler than the north end. Thin sections were not made between 10.5 and

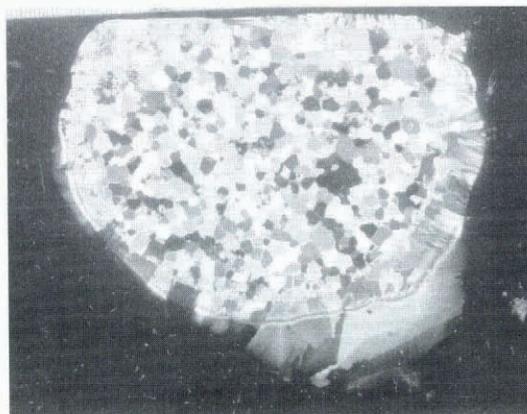
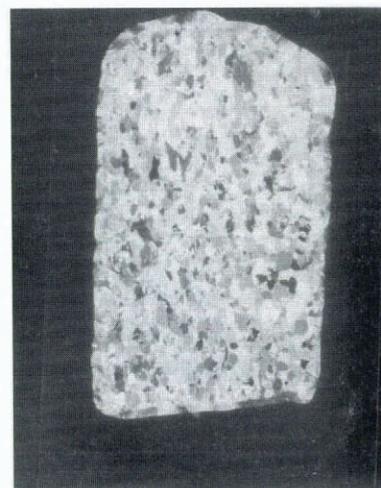
Fig. 8. Horizontal (top) and vertical thin sections at 10.3–20.5 cm horizon of core sample removed from the Pegasus runway surface at the 0 m zone (north end).

At the north end (0 m) the core between 10.3 and 20.5 cm depth shows grain-sizes from less than 0.5 up to 5 mm in diameter and they appear to be somewhat oriented (Fig. 8). This ice also appears to be firm. Above this depth, the ice seemed to be meltwater-derived but the ice was too damaged to make a thin section.

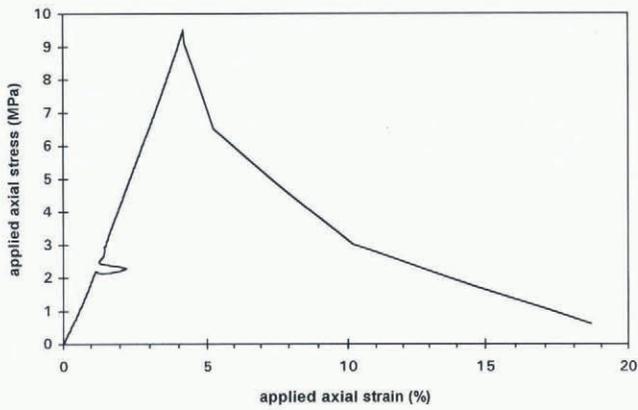
Fig. 9. Stress–strain curve from ice at a depth of 10.5–15.5 cm; extracted at the south end of the runway (3050 m). Applied loading rate was 44.5 kN s^{-1} .

Figure 9 shows the stress-strain curve from ice at a depth of 10.5-15.5 cm; this is snow-derived ice (i.e. glacial ice). The applied loading rate was 44.5 kN s^{-1} , which is the approximate loading rate of the C-141 tire rolling at 1.7 km h^{-1} . During proof-rolling, the load cart moved about 3.3 km h^{-1} . The test temperature was -10°C . Figure 9 shows a clear linear relationship between stress and

strain to failure. This is indicative of a brittle failure mode in the ice. The failure stress is approximately 10 MPa.

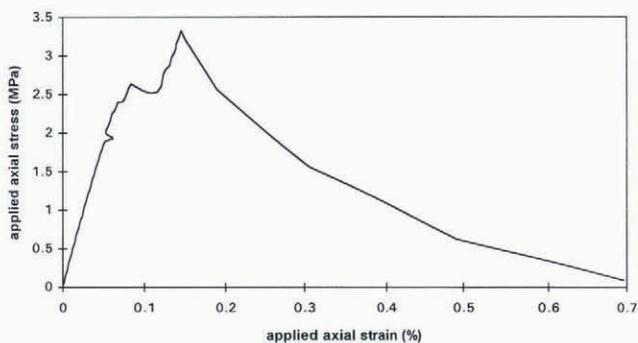
Fig. 10. Stress–strain curve from ice at a depth of 20–27 cm; extracted at the south end of the runway (3050 m). Applied loading rate was 44.5 kN s^{-1} .

The test results in Figure 10 are for an ice sample at a lower horizon (20–27 cm deep). Its failure strength is approximately one-third that of the sample that was closer to the surface. This may be a grain-size effect; grain-size increased with depth at the south end of the runway. Larger grain-sizes generally correspond with reduced strength (see, e.g., Schulson, 1990). Figure 10 also depicts a strong linear stress–strain relationship, verifying that brittle failure should be expected in this load and temperature regime.

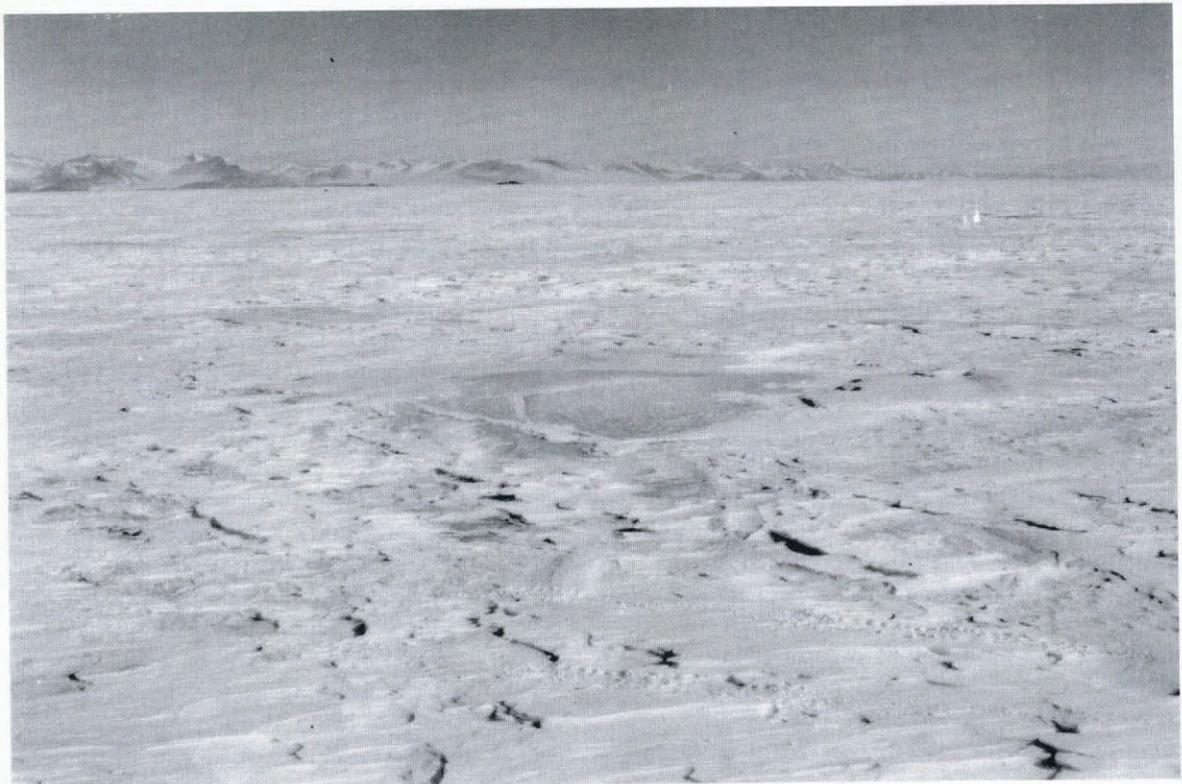
Fig. 11. Site of former melt pools on the ice shelf. They are easily identified by surface blisters that can frequently be very large and have distinct radial tension cracks.

occurs during refreezing. Sites of former melt pools on the ice shelf can easily be identified by surface blisters that can frequently be very large and have distinct radial tension cracks (Fig. 11).

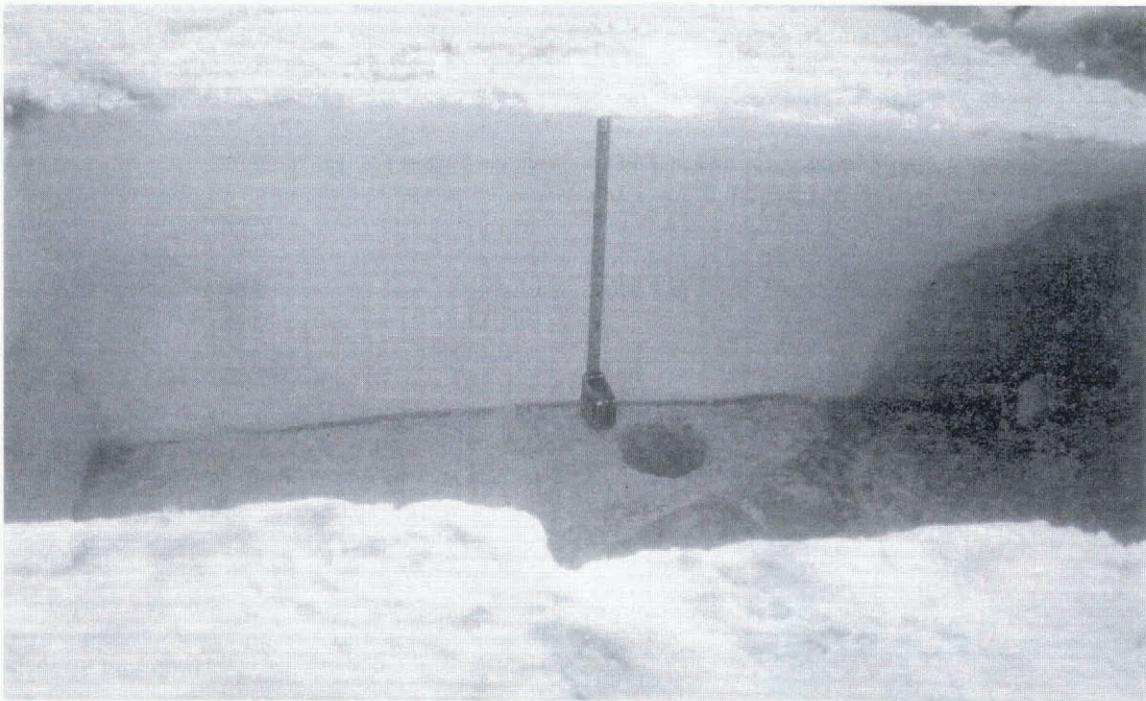
Fig. 12. Cross-section of ice blister showing gap between upper meltwater ice and lower glacial ice.

Because of the spotty occurrence of melt pools in the particular area of the Pegasus runway, some sites (those with a chronic lack of snow cover) may form melt pools annually. Other areas may have never experienced melting and refreezing. A giant cross-section of the area in the winter, when everything is frozen, would most likely display elongated pods of large-crystal "blue" ice scattered along near the surface and embedded within fine-grained, milky glacial ice. Klokov and Diemand (1994) have dissected a frozen melt pool and described its features, including a gap at the meltwater–glacial ice boundary (Fig. 12).

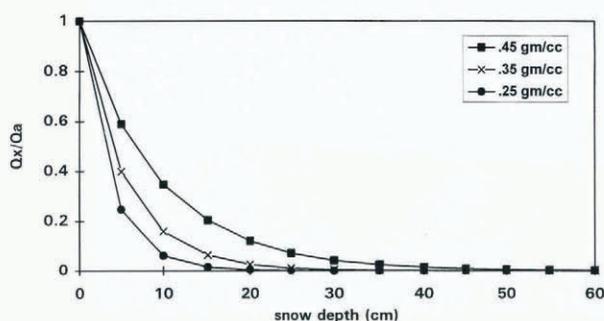
Fig. 13. Ratio of radiation intensity absorbed at depth x , (Q_x) to intensity absorbed at snow surface (Q_a) as a function of snowpack thickness and density.

Pegasus runway, the primary objective of the runway management crew should be to protect the runway from melt-pool formation (sub-surface and surface types) during periods of peak insolation. This can be accomplished by covering the runway with snow during late November, December and early January. Runway design criteria call for it to be covered with a 35–40 cm layer of snow from the end of November until mid-January. The snow reflects a larger percentage of the incoming radiation and attenuates what is absorbed, thus protecting against melting of the ice (Fig. 13).
