## THE SHAMASH GATE, NINEVEH: A WINDOW INTO TWO EPISODES OF INSTABILITY

By TIMOTHY HARRISON, KHALED ABUJAYYAB, STEPHEN BATIUK, ELIZABETH GIBBON,  
GIANNI MARCHESI, BRYNN EVANS, RULA SHAFIQ AND ALESSANDRO FONTI

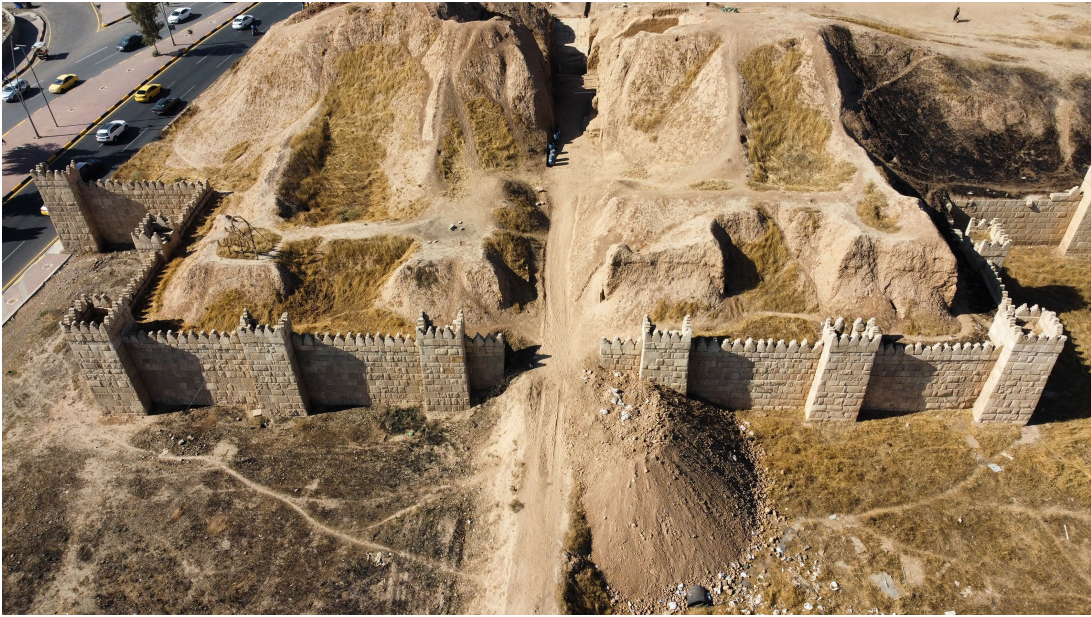
Fig. 2. Aerial Photo of the Shamash Gate from the east

The Shamash Gate is one of eighteen gates that provided access to the city of Nineveh and it is considered one of the largest gates to the city (Fig. 2). According to textual sources (Grayson and Novotny 2012: 18), the construction of the gate occurred as part of the extensive expansion of the city during the reign of King Sennacherib (705–681 B.C.E.). This construction history is supported by inscriptions on the orthostats that line the lower parts of the inner gate walls and towers (Fig. 3). Our recent work at the gate also suggests that renovations to the gate took place during the reign of King Ashurbanipal (669–631 B.C.E.) and/or earlier (see below). The gate provided access to the city from the east along the road connecting Erbil to Nineveh (Reade 2016: 73). Within the city, the Shamash Gate also provided access to the main thoroughfare leading from the eastern wall to the mound of Nabi Yunis and Esarhaddon's (680–669 B.C.E.) royal palace in the west.

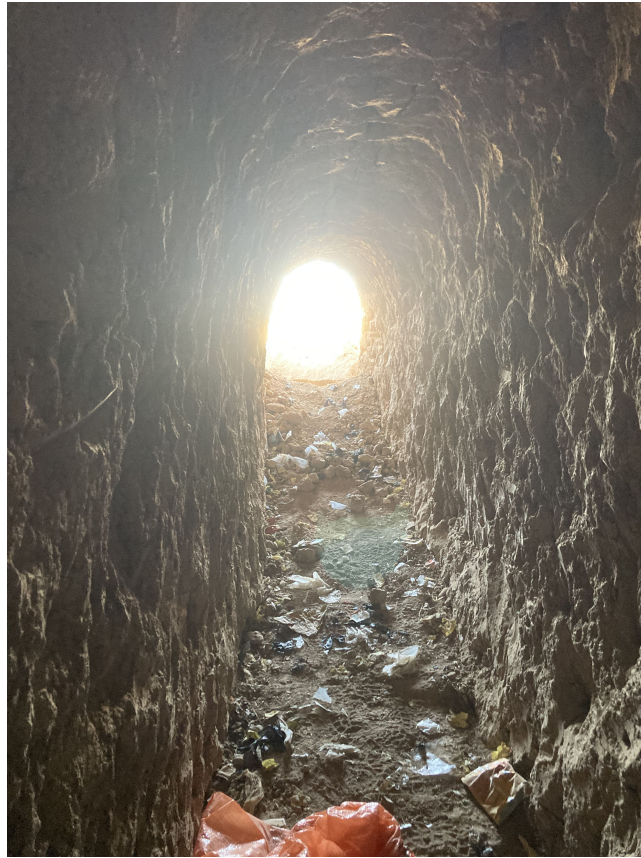
Fig. 4. Photo of ISIS tunnel

In 2016, in preparation for the anticipated attack on Mosul by the Iraqi-led coalition, ISIS began developing defenses to retain control of the city of Mosul. As part of this preparation, ISIS established networks of tunnels throughout Mosul and its surrounding villages. With an anticipated advance from the east along the Al-Khazer and Baashiqqa axis, the Shamash Gate, the major eastern entrance to the Neo-Assyrian city along the Erbil-Mosul road, was identified as a main point of defense, and a series of tunnels was excavated, largely beneath the foundations of the gate complex.

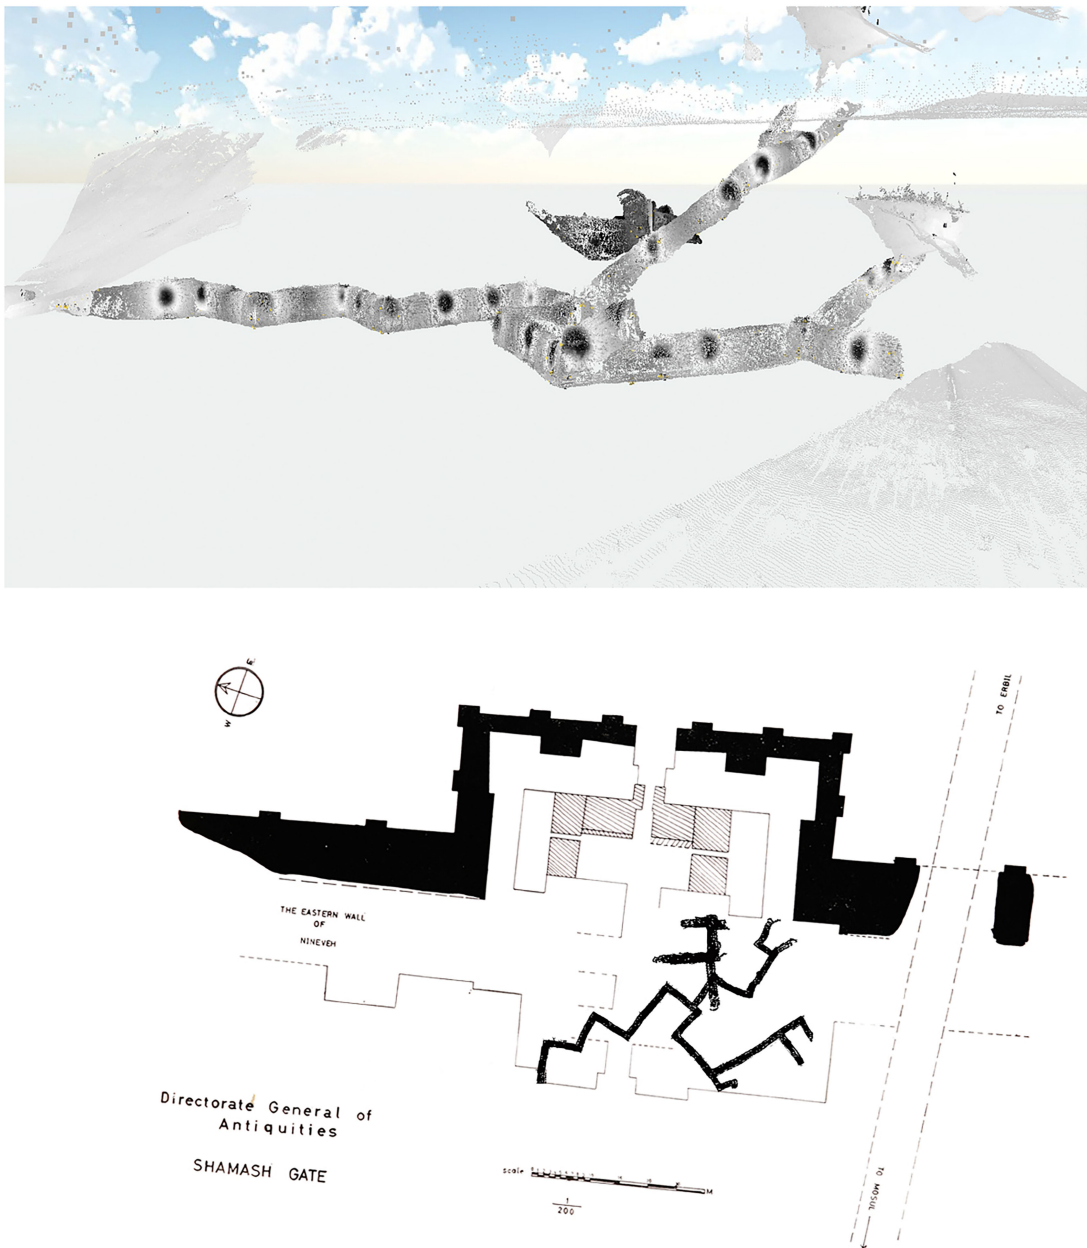
Fig. 6. 3D mapping of ISIS tunnel network

More systematic investigations of the tunnels occurred in 2021 (September 26 to October 15). Their primary aim was: (1) to thoroughly document the tunnels, and (2) evaluate their potential threat to the stability of the Shamash Gate complex. A FARO Focus 3D Laser Scanner was used to produce a comprehensive 3D image of the tunnels (Fig. 6). Systematic visual inspection also indicated that on occasion the ISIS excavators had broken through, or damaged, *in situ* orthostats and the stone pavement of the central gateway. In some instances, they smashed through the stone to continue their excavations, and in others, they attempted to work around the stone foundations of the gate complex, resulting in numerous dead-ends. The network of tunnels ran primarily under the foundations of the gate complex, but on occasion, tunnels were cut through stone and brick structures, ascending via a series of ramps and steps, and exiting at the top of the gate's walls. The 2021 season's investigations identified a clear threat to the stability of the Shamash Gate complex and the imminent danger of its collapse.

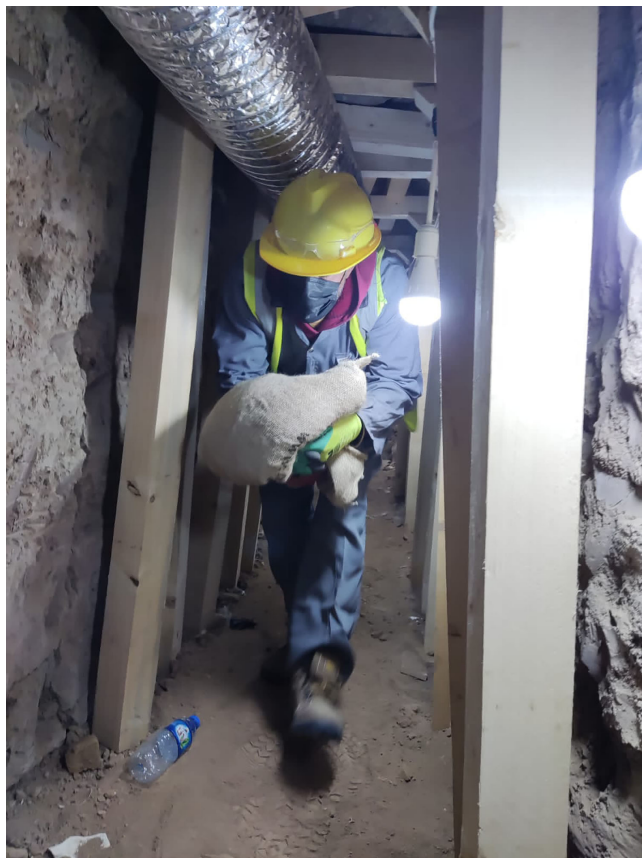
Fig. 7. Member of UNDP Team filling the tunnels

Fortunately, consultations following the 2021 season resulted in a collaboration with the United Nations Development Program's (UNDP) team involved in the ongoing rebuilding of Mosul. In February and March 2022, with funding through the Peace and Stabilization Operations Program, the UNDP undertook the successful stabilisation of the ISIS tunnels that undercut the Shamash Gate. This effort resulted in the structural stabilisation of the tunnels, which were then backfilled completely with sandbags containing the soil originally excavated by ISIS (Fig. 7).

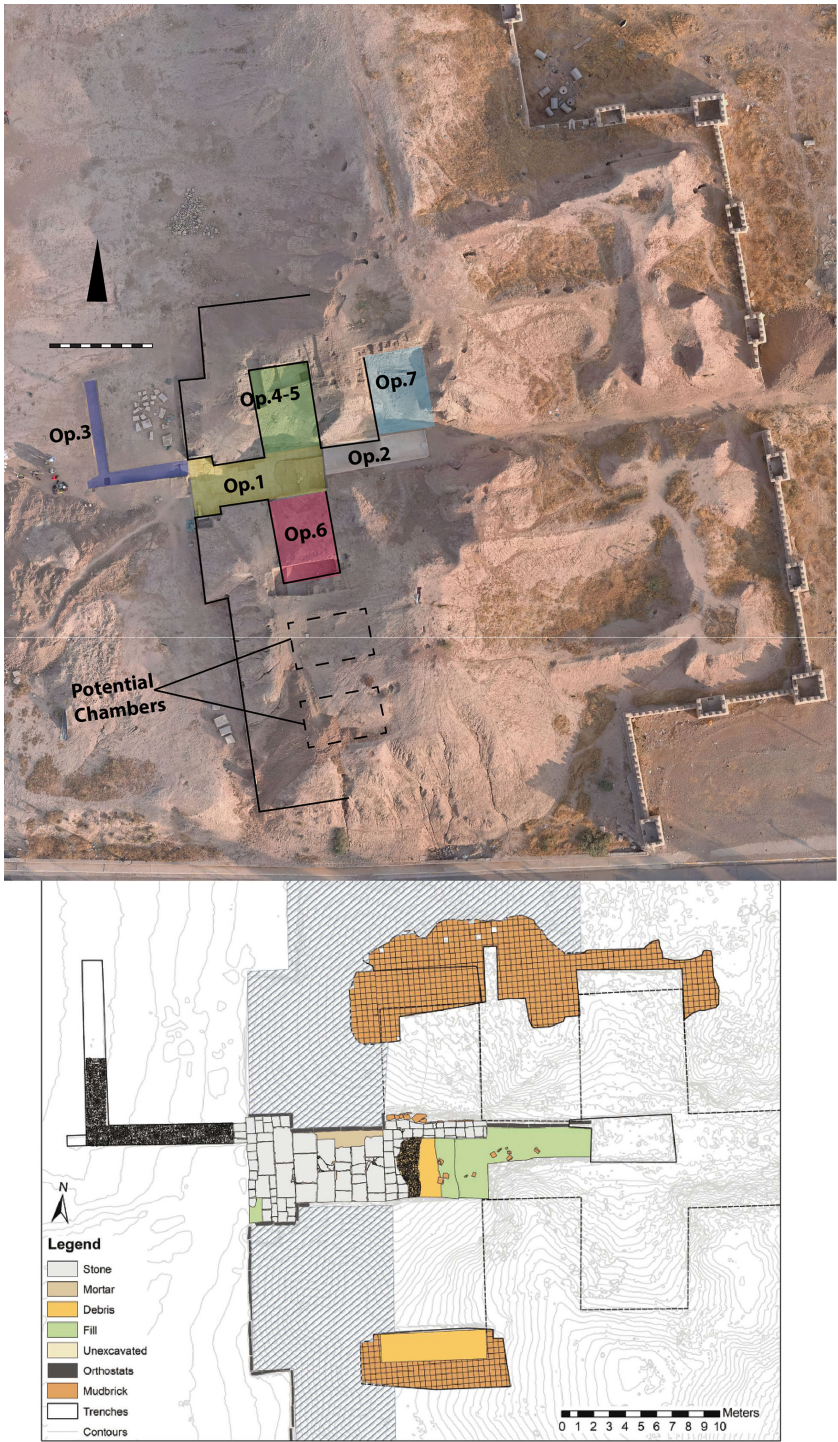
Fig. 8. Plan of the Shamash Gate

Seven discrete operations have been excavated within the Shamash Gate to date. These operations are distributed across four different sectors of the gate (Fig. 8): the main central passageway, the northern flank of towers and rooms, the southern flank of towers and rooms, and the interior to the gate.

Operation 1 consists of the western portion of the passageway within the gate system (Fig. 8). The excavations in this area identified fairly secure contexts dating to the late seventh century B.C.E. and produced a wide range of artifacts including large numbers of stela fragments, partially articulated human remains, bronze and iron arrowheads, ceramics, and a decorated bone button (Fig. 9). Initial excavations in 2022, and more thorough investigations in 2023, confirmed that there were at least two phases of pavements within the gate system.

Operation 2 formed an eastern extension of Operation 1 inside the central passageway of the gate. The trench was rectangular in shape and extended from the edge of the inner-most pier to just before the central pier, with a length of 10 m and a width of 3.3 m (Fig. 8). This trench was cut along the

Operation 6 was located in the southwest tower of the gate system. The objectives of the operation were similar to those of the operations in the northwest tower; that is, understanding the outlines and dimensions of the chambers/courtyard off the gate's central passageway. The two western-most towers were asymmetrical: the northwest tower was roughly 13 m wide, and the southwest tower was almost three times wider. This may indicate that there were two or three chambers in the southwest tower, a possibility further supported by the depressions seen in the topography of this area (see Fig. 8).

Operation 3 (Fig. 8) was an L-shaped probe designed to understand the area immediately inside the gate (see Petit and Morandi-Bonacossi 2017: 125). The excavations completed to date have

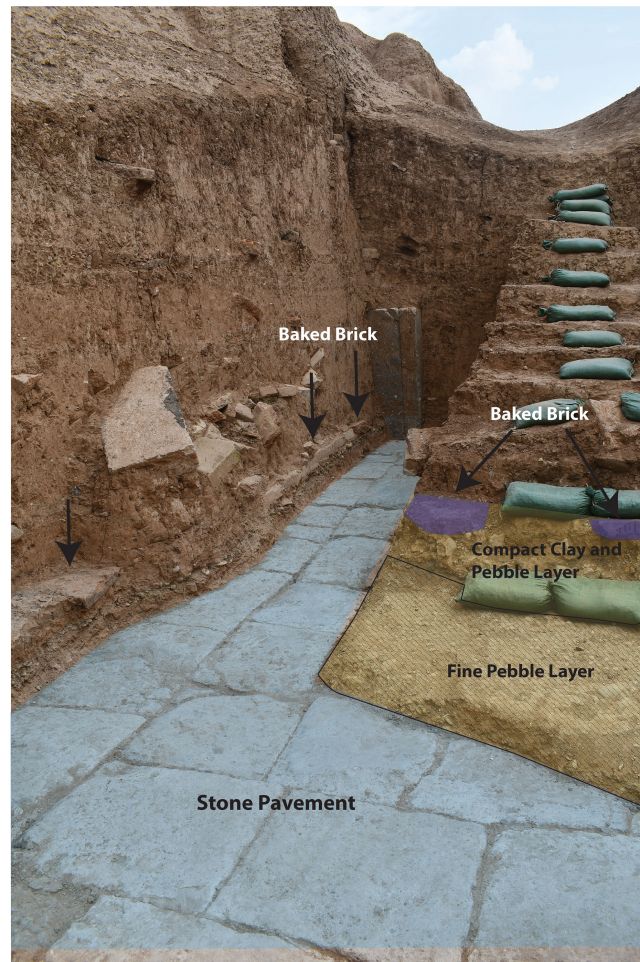
Fig. 10. Details of pavement sequence in operations 1-2

The earlier phase pavement consisted of large stone blocks of different sizes, perhaps laid out as part of the construction of the gate during Sennacherib’s (705–681 B.C.E.) expansion of the city

(Reade 2000: 396–399). The upper pavement is less clear in terms of its composition, due to its patchy preservation in Operation 1. The pavement appears to have been constructed of three layers, with an initial layer of mudbricks and fill present in some sections meant to level the floor (where the stone pavement may have dipped). A second layer of fine pebbles embedded in a hard clay matrix, which constituted the base of the pavement, lay on top of the bricks, occasionally resting directly on the stone pavement (Fig. 10). This second layer was the most coherent and was preserved in better condition than the upper layer of the pavement. The third layer seems to have been a fill formed of compact clay with interspersed pebbles and fragments of broken baked bricks. Embedded within this layer (Loc. 2881), were fragments of the stela, as well as human remains and other artifacts. In addition to the sequence observed in the passageway, the side chambers appeared to have been paved with baked bricks (visible in the section on the left in Fig. 10). Traces of a conflagration, manifest as pockets of ash and charcoal, were also noted in the area of the dense concentration of artifacts.

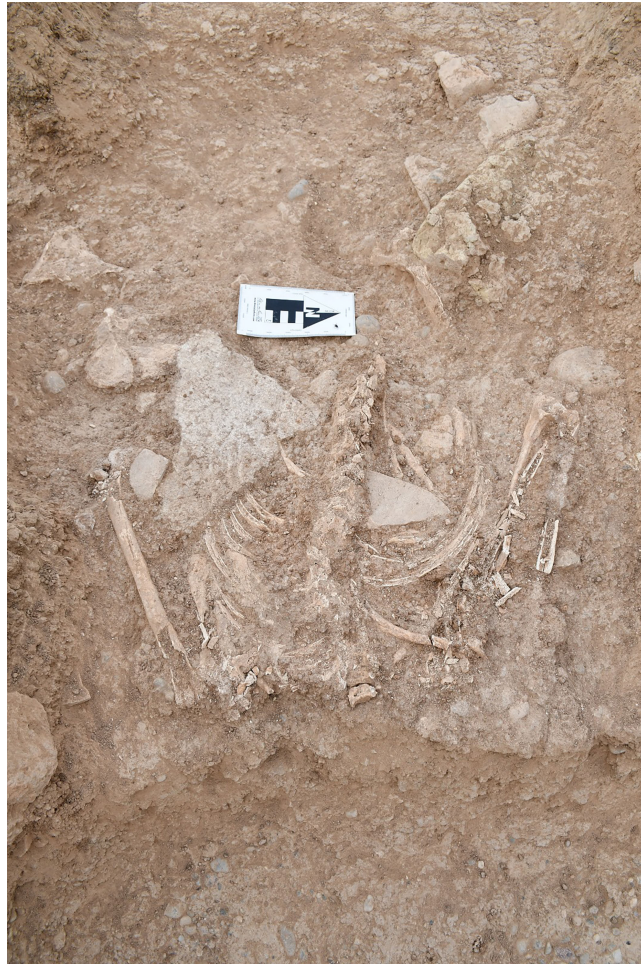
Fig. 11. Individual skeleton in operation 3

identified two surfaces. The lower surface was composed of medium-sized river pebbles embedded in a clay matrix. We are not sure if this surface was artificial, or whether it formed the natural geological composition of this area's surface at the time of use, pressed and compacted as a result of repeated treading (see Madhloom 1968). The upper surface was completely different, composed of clean red clay with fragments of baked brick embedded within it. The remains of a partially articulated individual were uncovered on this surface (Fig. 11).

At the west (inner) entrance of the Shamash Gate, the poorly preserved remains of an adult individual were found in a face-down position (Fig. 11), with both upper arms at the sides of the

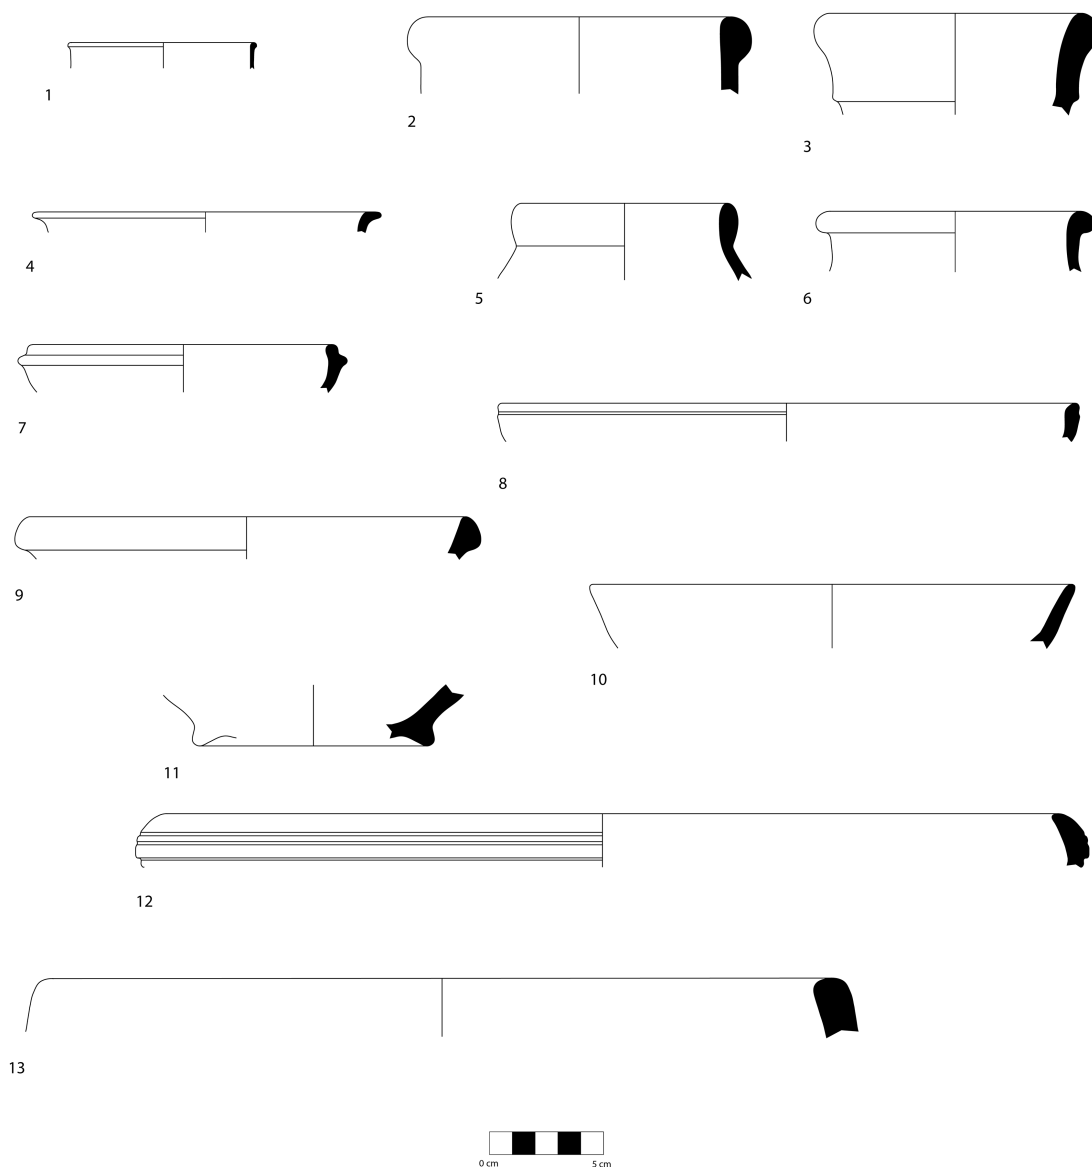
Fig. 12. Plain wares from the Shamash Gate

typology created from the Mashki Gate excavations in 1989 and 1990 (Wilkinson and Lumsden 2022). As at the Mashki Gate, the primary Shamash Gate vessel forms were bowls with beaded rims (Type B1b<sup>2</sup>) (Fig. 12.8), bowls with ribbed rims (B2) (Fig. 12.7), bowls with tapered rim (B3) (Fig. 12.10), small to medium bowls with grooves on the rim (B4a) (Fig. 12.12), bowls with everted externally thickened and projecting rims (B6b) (Fig. 12.4), jars with folded out-turned rims (J1a) (Fig. 12.3), jars with externally thickened rims and long necks (J2) (Fig. 12.2, 6), and jars with folded or thickened rims and short or no neck (J3) (Fig. 12.5).

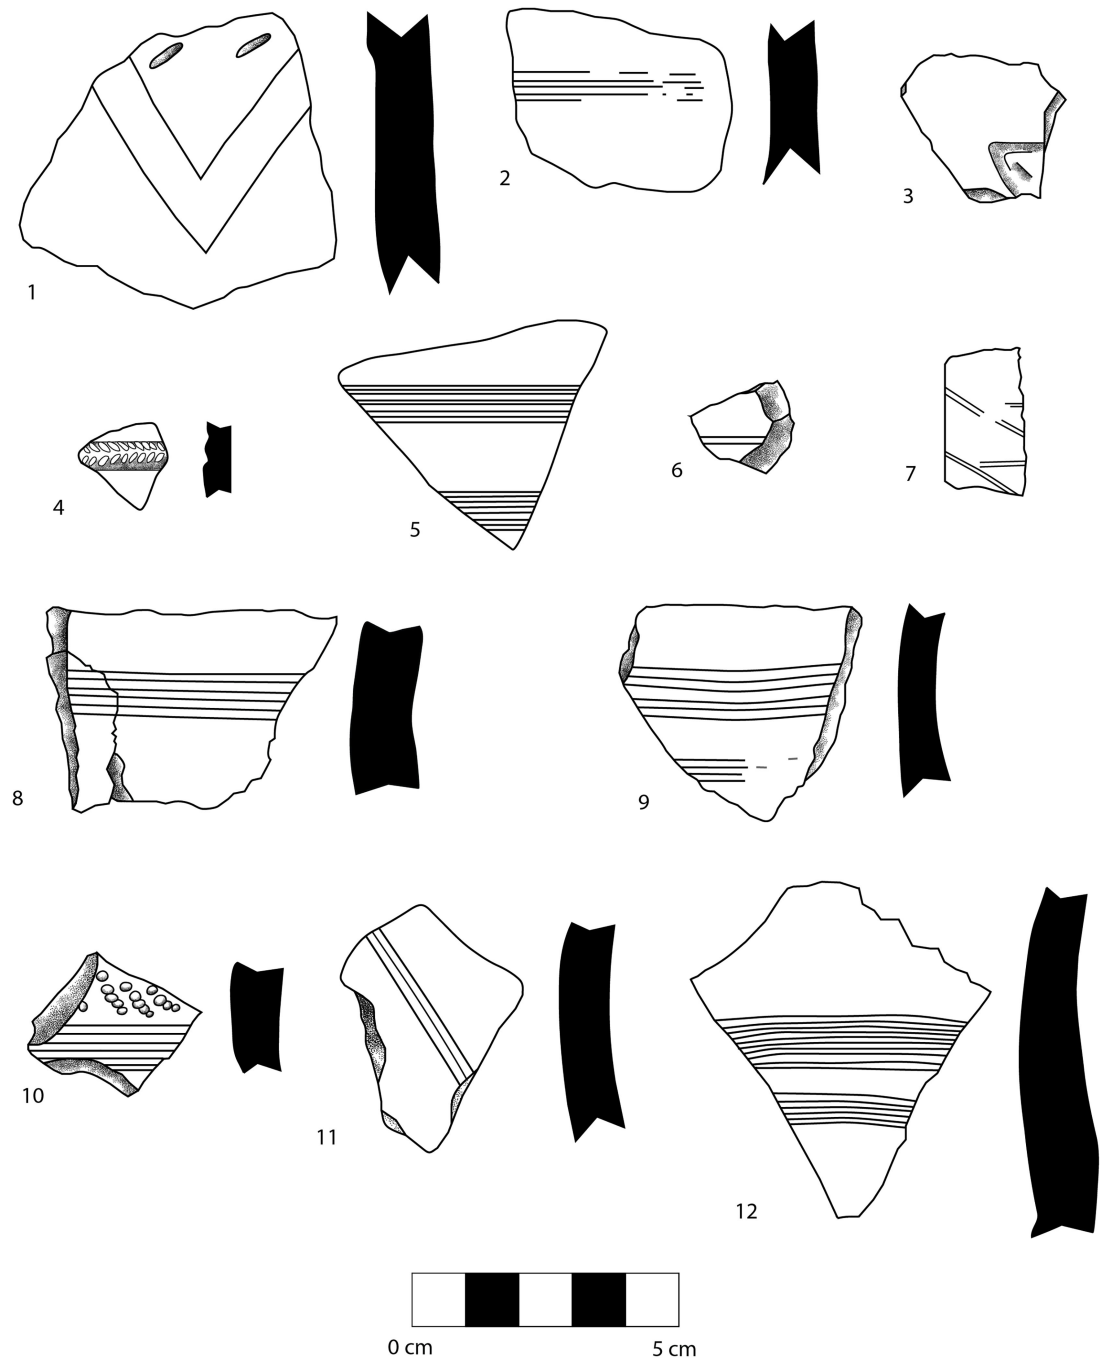
Fig. 13. Incised Wares

The primary surface treatment consisted of wet-smoothing, and in one circumstance, red slip on the interior and exterior of the sherd. The primary decorative style involved variations of banded incisions, comb impression and punctates. More specifically, the types of decoration included two v-shaped incisions creating bands with punctates, horizontal incised combing, horizontal incised combing with small punctates, diagonal incised lines, small braided applique, triangular incised lines with punctates, parallel horizontal and diagonal incisions creating a y-shape, and glaze. It is worth noting that only one or two examples of each of these decorative styles were recovered, and only twenty sherds in total had preserved decoration (Fig. 13).

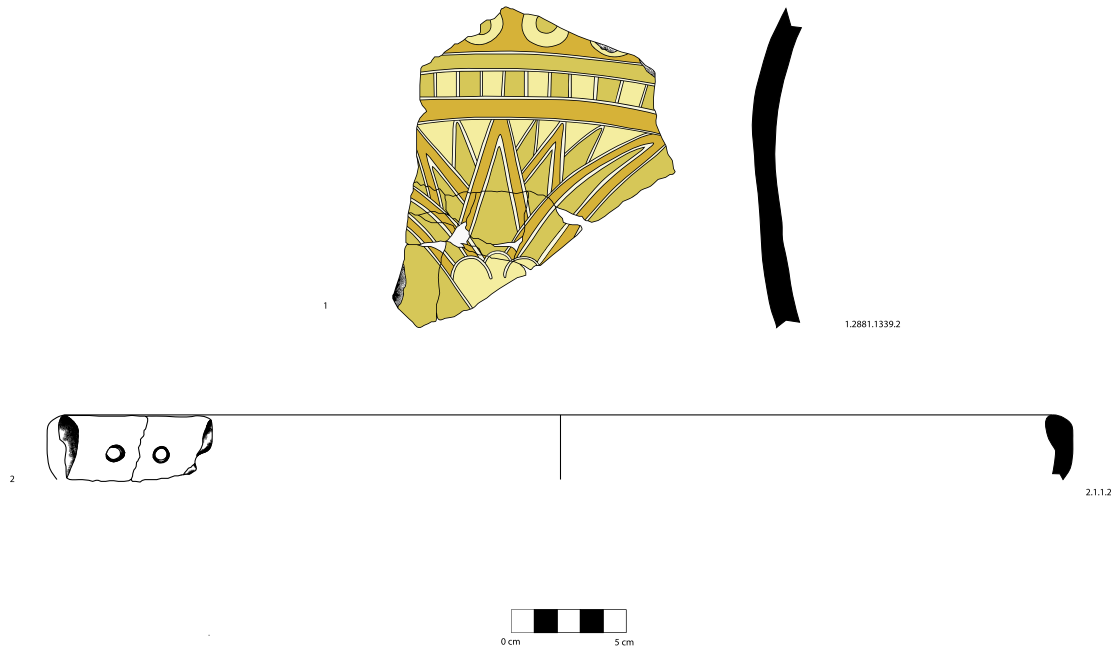
Fig. 14. Unique sherds

A vibrant Assyrian glazed ware body sherd was uncovered in Operation 1 in a hard compact surface (Fig. 14.1). It was found face down, and when lifted, it left a residual imprint of the vibrant glaze on the soil. The glazed pattern on the exterior of the sherd consists of a row of circular dots at the top and horizontal bands of solid and checkered shades of yellow glaze below this. A lotus flower motif was preserved towards the bottom of the sherd. The glaze alternates different shades of yellow, and each decorative element is bordered by a small white line, further accentuating the decoration. The interior of the sherd had a white glaze. Pottery with similar geometric decoration and yellow and white glaze was recovered from the Neo-Assyrian and Post-Assyrian levels at the Mashki Gate (Wilkinson and Lumsden 2022: 53).

Another unique sherd was found in Operation 2, in a mixed context within a layer of compact mudbrick fill (Fig. 14.2). The rim has two fully intact perforation holes, as well as two partial perforation holes on the broken edges, suggesting the associated vessel had been mended. Finally, excavations of a compact clay fill in the northwest tower (Operation 5) produced a small fragment of clay slag.

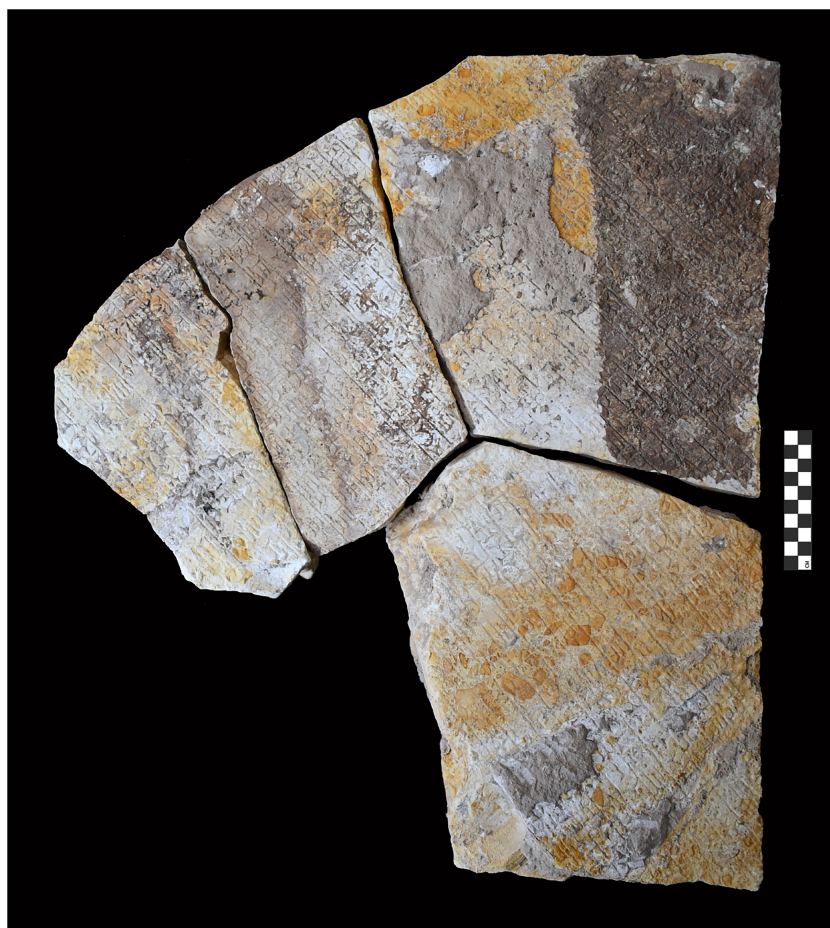
Fig. 15. Stele fragments

To date, 196 fragments of various sizes have been retrieved (Fig. 15). Most are too small to provide continuous and consistent text and to allow the identification of duplicates; some parts are irreparably damaged and no longer readable. The original size of the stela is unknown. Based on the proportions of the discernable fragments found thus far, the monument was not less than 2 m in height, about 80–100 cm in width, and 26 cm in thickness. Evidence of its intentional (and violent) destruction, presumably during the fall of Nineveh in 612 B.C.E., are seen in the highly smashed and varied sizes of the surviving fragments, including the presence of numerous small chips and flakes.

The stone shows a severe decohesion of its surfaces and a very weak resistance to scratching. However, this condition is patchy and uneven, and in some parts, the stone matrix appears compact, with the characteristics of limestone. Traces of fire and burned organic remains (maybe straw) were found in the clay matrix that sealed its surfaces. The compactness of the clay is diverse: very dry and soft in places, but harder than the stone itself in other parts. In the most degraded parts, the clay pressed into the incised cuneiform signs occasionally retained the outline of the text where the surface of the stone had been lost. It is possible the stone became calcified from the intense heat of a fire at the time of its destruction, possibly inadvertently shattering the stone.

The conservation of the stela fragments involved an initial ‘light’ cleaning, which succeeded in removal of most of the clay from their surfaces. Three types of clay layers were discerned on these surfaces: (1) a soft clay layer, not very compact, with a thickness from 1 to 2 cm; (2) a hard clay layer, more compact and strongly attached to the stone surface, with a thickness from 1 to 2 mm; and (3) a layer composed of the original stone surface and clay, completely penetrating the stone, with a thickness in micrometers. The softer clay was removed by moistening it with a contact sponge, waiting a few minutes, and then extracting it with the help of a scalpel. Where this layer was hard to remove, it was thinned with the help of a hammer and chisel and then completely removed with an ultrasonic scaler. The harder clay layer was removed using the scaler and subsequently finished with scalpel and probes. The third layer of clay, which had congealed with the stone surface of the stela, was very thin and impossible to remove during this initial phase of conservation. It is visible as a dark brownish stain

on those surfaces where it remains. All of the fragments, except two, required consolidation before they were cleaned. In most cases, this involved an acrylic resin (Acril33) mixed at 10% in water.
