Innovative Grounding Methodology for Epoxy Impregnated Semiconductor Cross Sections for Electron Microscopy Inspection

Frieder Baumann, Pradip Sairam Pichumani and Christopher Torcedo

Globalfoundries, Inc., Malta, New York, United States

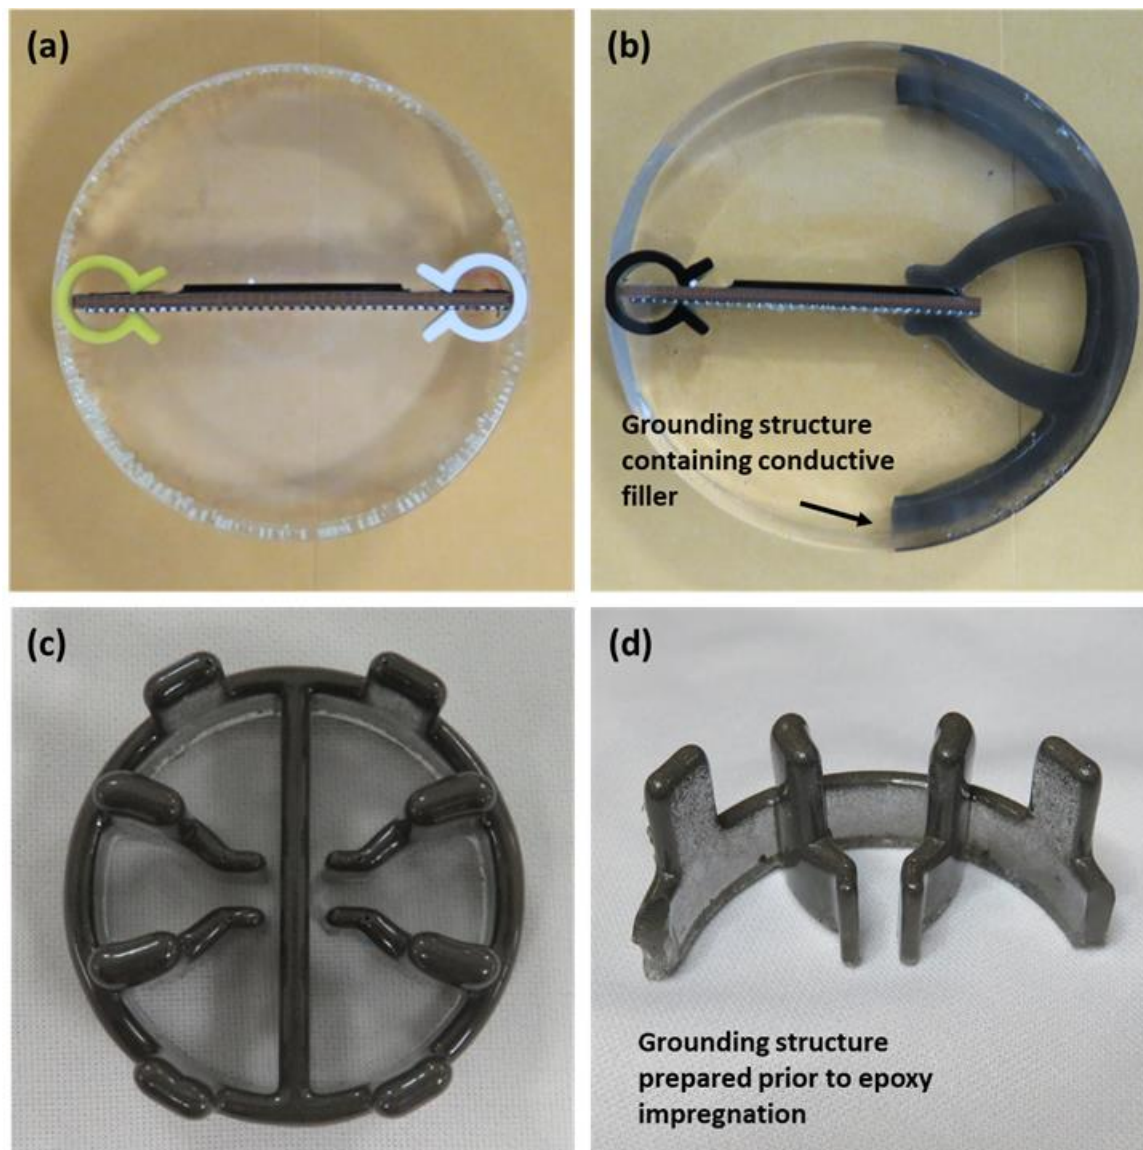
Figure 1. Optical image of (a) a conventional epoxy puck, (b) epoxy puck with grounding structure, (c) & (d) grounding structure prepared prior to epoxy impregnation of the sample

In this study, the authors compared conventionally prepared epoxy puck with the modified puck with grounding structures as shown in figure 1. Both the types were Cr coated prior to SEM imaging for a period of 100 seconds in order to establish the grounding structures as the only variable component in the study. Charging artifacts were not observed in the case of epoxy puck with grounding structures, while severe image distortion was observed in the case of conventional epoxy as shown in figure 2. Future work includes a slotted design in conventional epoxy puck to remove the cross sectioned sample upon completion of the polishing process [3].
