EBSD-Analysis of Microstructural Changes Below Wire-EDMed Surfaces

A. Schwedt¹, L. Hensgen², J. Dieckmann², A. Klink², F. Klocke², and J. Mayer¹

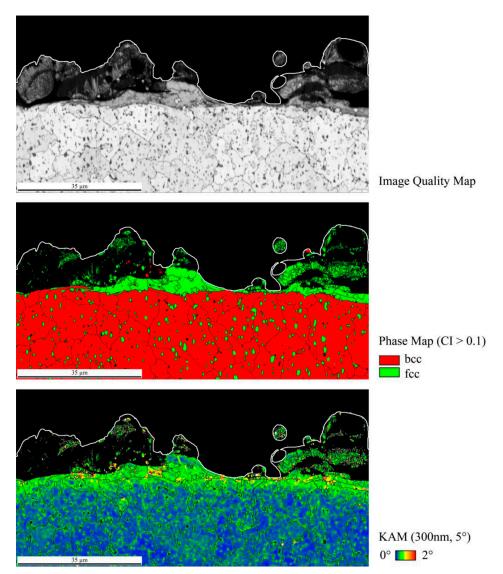
Figure 2. Microstructural changes in terms of crystallinity, phase content and local deformation state after the main W-EDM cut of a X140 CrMoV 5-4-4 PM cold work tool steel. The white line represents the actual surface, marked by Au coating before the preparation.

Depending on the actual parameters of the W-EDM process, several degrees of microstructure alteration were found (cf. Fig. 2). The topmost layer usually is an amorphous or nanocrystalline layer, the crystallites of which would be too small to be measured with EBSD, corresponding to the 'white layers' which can be observed in LOM or BSE images in the SEM. This layer often also implements material from the cutting wire. Below this, a layer of crystalline, but phase-transformed material can be found. The occurrence as well as thickness of these two layers can be significantly reduced by trim cuts following the main cut.

Further below, the base material did not undergo any phase-transformation, but still shows plastic as well as elastic deformation which can be seen in the local misorientations in the base material.
