THE CONTRIBUTION OF DISCONTINUOUS ROCK-MASS FAILURE TO GLACIER EROSION

Ken Addison

(The Polytechnic, Wolverhampton WV1 1LY, and St Peter's College, Oxford OX1 2DL, England)

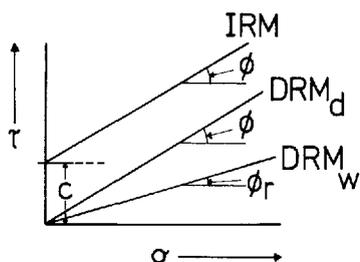
Fig.1. Linear Mohr-Coulomb relationships between shear stress and normal stress for intact rock mass (IRM); the progressive reduction in required shear stress is shown for dry discontinuous rock mass (DRM_d) where $C = 0$, and wetted discontinuous rock mass (DRM_w), where a given friction angle ϕ is reduced to an effective friction angle ϕ_r .

The failure criteria for rock is usually defined by a simple linear Mohr-Coulomb equation (Fig.1):

$$\tau = c + \sigma \tan \phi, \quad (1)$$

where τ and σ are shear and normal stresses, respectively, c is the value for internal

cohesion, and ϕ is the angle of friction along the eventual failure plane (Hoek 1970). A distinction is made between *peak* shear strength, beyond which the rock deforms, and the *residual* shear strength of the deformed mass. These may be similar for soft rock, whereas residual strength may be as little as half the peak strength for hard igneous rock (Hoek and Bray 1974). Typical intact rock shear strengths and other properties are shown in Table I.

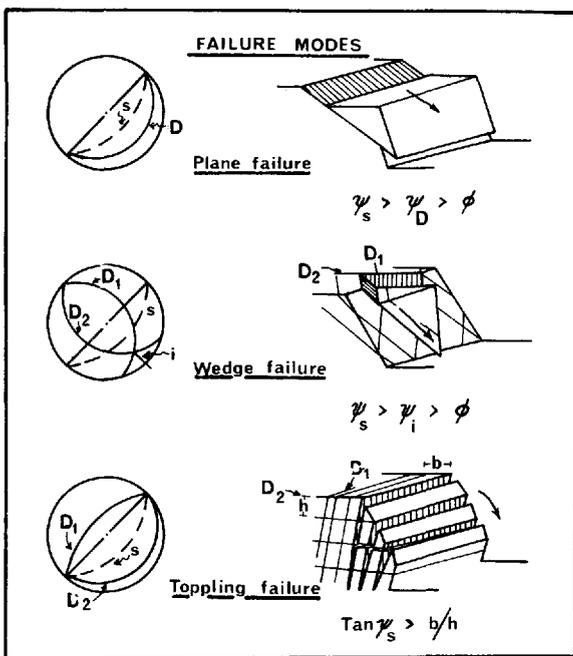
Fig.2. Failure modes and their related discontinuity stereonet (equatorial equal-area lower hemisphere projection).

Probable failure modes on unstable slopes can be determined from the relationship between the excavated slope and discontinuity geometry. Three of four principal failure mechanisms recognized in slope engineering are considered here (Fig.2). (*Circular failure* is disregarded for DRM with well-defined discontinuities.)

Plane failure (of single or multiple slabs) occurs when

$$\psi_s > \psi_d > \phi, \quad (7)$$

and *wedge failure* occurs when

$$\psi_s > \psi_i > \phi, \quad (8)$$

where ψ_s and ψ_d are the slope and discontinuity angles and ψ_i is the angle of the slope of intersection of two planes defining a wedge. (The excavated slope must permit the potential failure planes to "daylight".) Failure, particularly in the case of planar slides, requires the presence of other release surfaces provided by other discontinuities.

Toppling failure occurs when the primary plane D_1 dips into the slope and is apparently stable, but also when a secondary stable plane D_2 is so spaced as to define a block whose centre

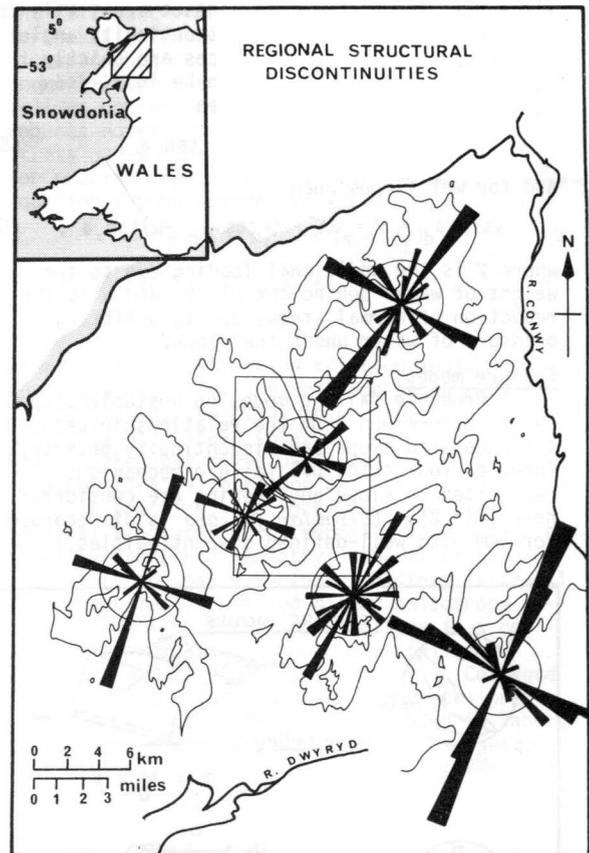
Fig.3. Frequency orientation diagrams of regional fracture systems for each of the six mountain groups of Snowdonia, mapped from stereographic air photograph cover. Circular scale shows 5 km. Inset outline shows location of Figure 4.

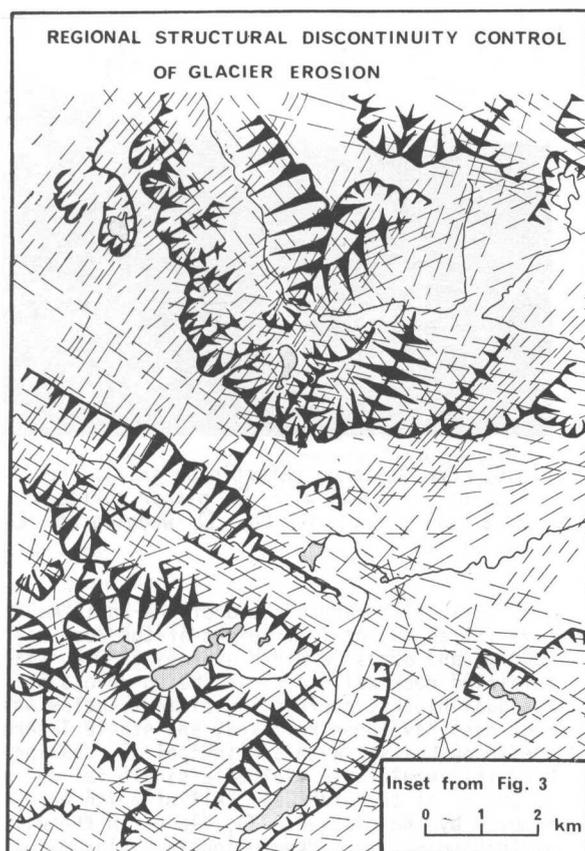
Fig.4. Primary fractures in the Snowdon (SW) and Glyder (NE) groups and principal glacier-eroded cirques and troughs. Fractures are shown by broken lines, cliffs by toothed shading, and lakes by stippling.

fracture geometry (Fig.4). In both cases, structurally controlled DRMF beneath and adjacent to the glacier bed is believed to have been the principal mechanism of excavation.

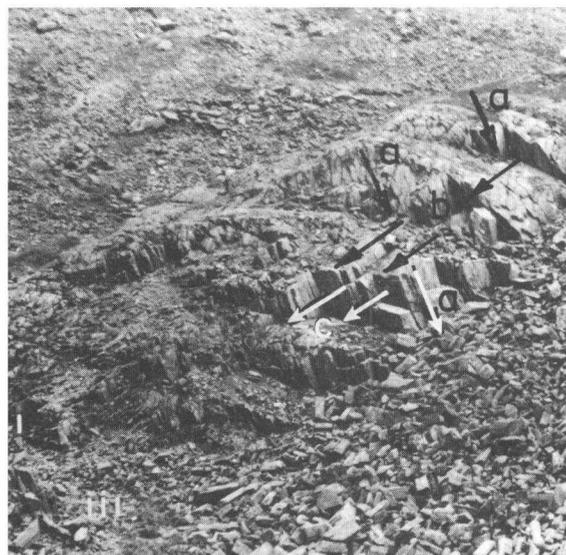
Fig.5. Ogwen valley floor. Sub-glacier confined DRMF, with secondary failure evident in excavated sections. Slab failure occurred along two planar sets (a, b) and toppling failure away from (c).

Bedrock floor in a major glacier-breached watershed is shown in Figure 5. Ice flowing from left to right first abraded the rock, followed by "quarrying" (displaced blocks show striations on one surface only) which removed some blocks altogether and displaced others; thereafter, gravitationally loaded secondary failure further dislocated the rock mass, at least in part sub-

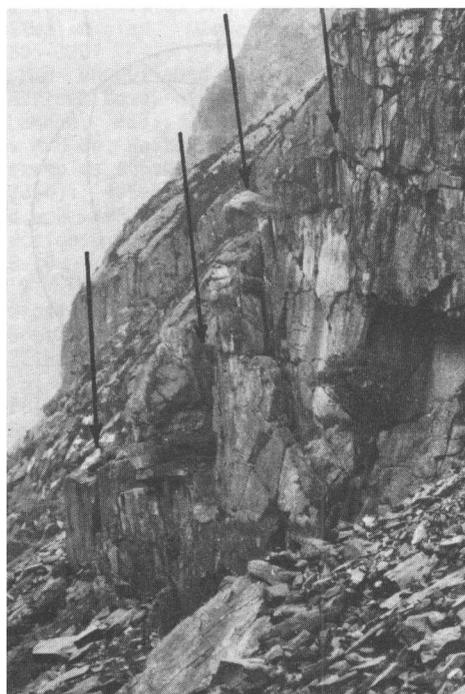
Fig.6. Toppling failure in Nant Peris; destabilization caused the parting of blocks along arrowed discontinuities.

Figure 6 shows an example of toppling failure towards the valley floor generated by the removal of adjacent rock mass under glacier confinement close to the valley floor. Cliff elements such as these are common, with at least the greater part of the failed rock mass absent from the toe; by comparison, the few remaining instable blocks which have recently toppled from the now unconfined face are all present at the toe, and exhibit less-weathered contact planes.

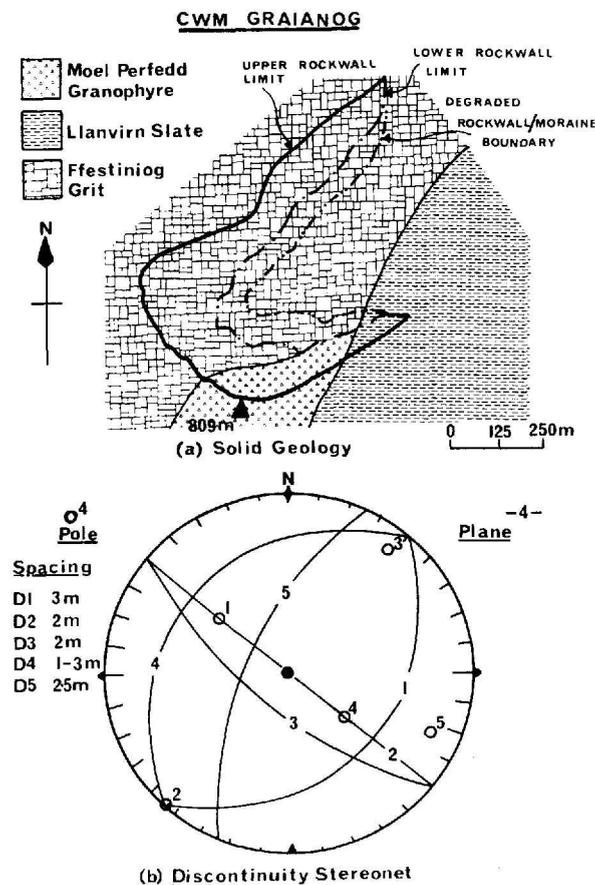
Fig.7. Bedrock map and discontinuity stereonet for Cwm Graianog.

This cirque basin affords one of the finest site concentrations of all modes of rock-mass failure in Snowdonia. It is excavated in Ffestiniog grit, and failure modes are discussed with reference to a standard structural presentation (Hoek and Bray 1974) shown in Figure 7.

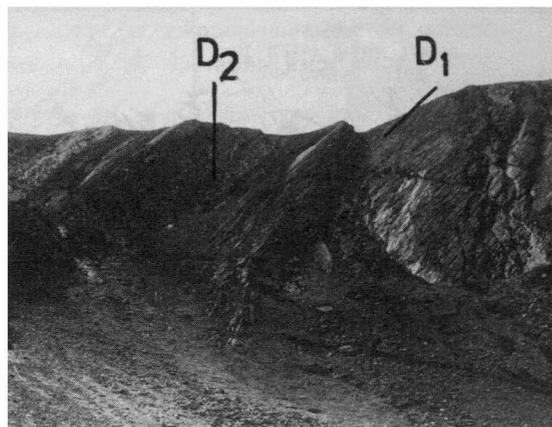
Fig.8. Cwm Graianog (Ffestiniog grit). North side wall (right) with D_1 planar surfaces; head wall (left) with D_1 - D_2 wedging and D_2 planar surfaces.

The north side wall consists almost entirely of a spectacular series of D_1 surfaces (Fig.8) and the slope angle is effectively the same as the discontinuity dip of $38-40^\circ$ to the south-east. Slab failure down D_1 was released along D_2 , which frequently possesses an injected quartz fill, and D_3 , and the vertical extent of individual slabs is limited by D_4 with the same strike, but opposite dip, as D_1 . One entire

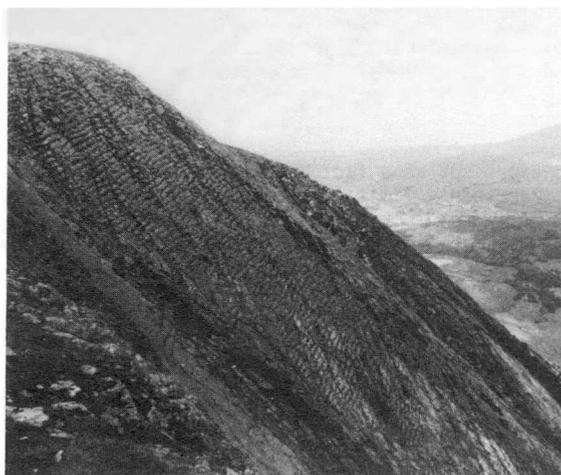
Fig.9. Cwm Graianog. Single D_1 major planar-slide release surface, (showing ripple marks).

slab towards the western end of the basin may have failed to the full height of the rock wall (200 m) and across a width averaging 60 m. The remaining rock wall is clean, being devoid of residual blocks, overhanging elements below which rock mass have been released, and stable laterally-confining units. With a principal D_1 spacing of 3 m, this would have yielded a single failure of $36\,000\text{ m}^3$ of the side wall, all of which was removed by the glacier. D_1 planes in the wall at this point are marked uniquely by large-scale bedding-plane ripples (Fig.9), and the only debris
